# PRESERVATION ARCHITECTURE

July 31, 2015

## PHOENIX CABIN HISTORIC STRUCTURE REPORT

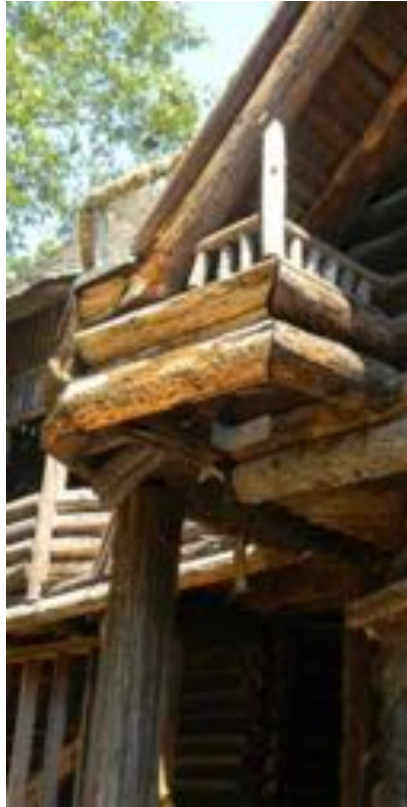
**Fig.37 – Log conditions at front gable ornamentation**

- Likewise, the ornamental logwork at the front gabled roof eaves should be removed and the original logwork repaired, including structural fixes to enable the removal of the wood post added to support the ornamental eave.
- At the rear porch, the previously added log railing that has also failed should be removed and either replaced with a more permanent wood railing assembly or, preferably, by extending the porch level into the landscape thus eliminating the railing requirement. The rear porch posts also require replacement.
- The ornamental window hoods at the living room bay windows are distinctive but are also far too fragile for their setting. They should be sturdily rebuilt or they may preferably be removed.

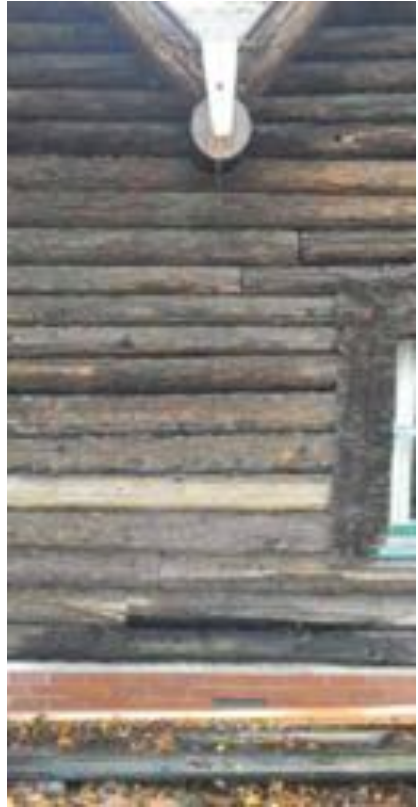
**Fig.38 – Log and roof drainage conditions at west side**

- Roofing – Cedar shingle. Areas of loss, especially at ridges, recently repaired. Leaks at west side valley between gables evident at interior – repair or replace waterproofing / flashing assemblies.

- At the roof, damage is evident in the form of leaking via the valley between the two gables. This area of roofing and flashing should be carefully inspected and repaired. It is also evident that debris builds up in this location – which may be part of the problem – so that roof area requires more regular maintenance. A couple of other factors are evident in this location: first, that the cricket is insufficiently sloped; and, second, that the copper scupper does not sufficiently reject water as it drains from the roof, instead allowing water to hit the lower wall, which is suffering as a consequence. A longer term reroofing solution would rebuild this roof area for more effective drainage.

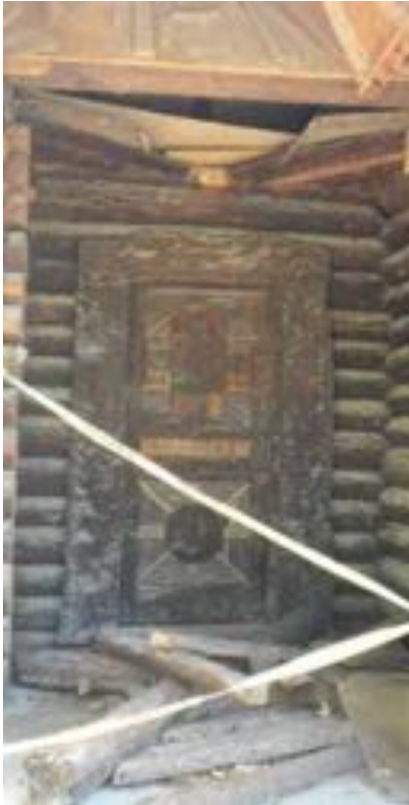
**Fig.39 – Structural conditions at front porch and entry door**

interpretation, inappropriately so, as the cupola is in fact structurally failing as well as purposeless. Thus, at the front porch, the porch roof and cupola should be removed and replaced with a new, simple front porch. Pre-1989 images of the Cabin show the front porch with a simple post-supported shed roof (fig.48). The front porch could also be redesigned to make the front entry accessible, if possible, from the fire road and/or from an adjoining parking space. A front patio-like area is an additional possibility, along with the possibility that such a space could be opened to the fire road or, if not fully open, with front gates that allow visibility and access at the front.

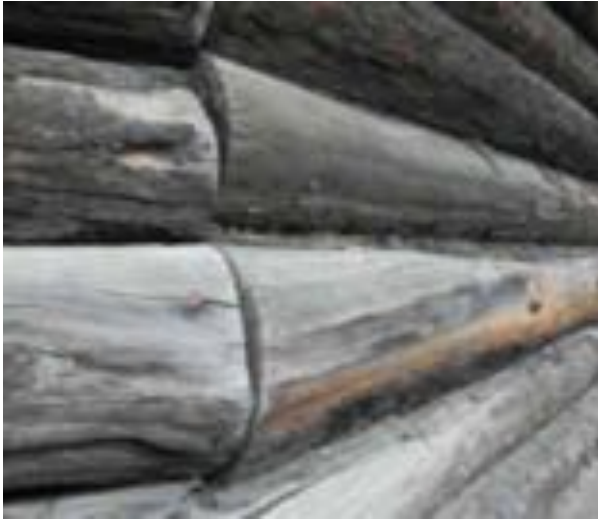
**Fig.42 – Log conditions at east side wall**

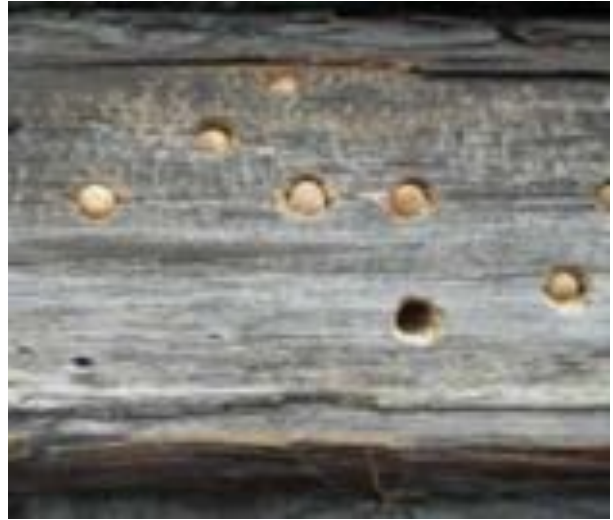
**Fig.43 – Log conditions at west side wall**

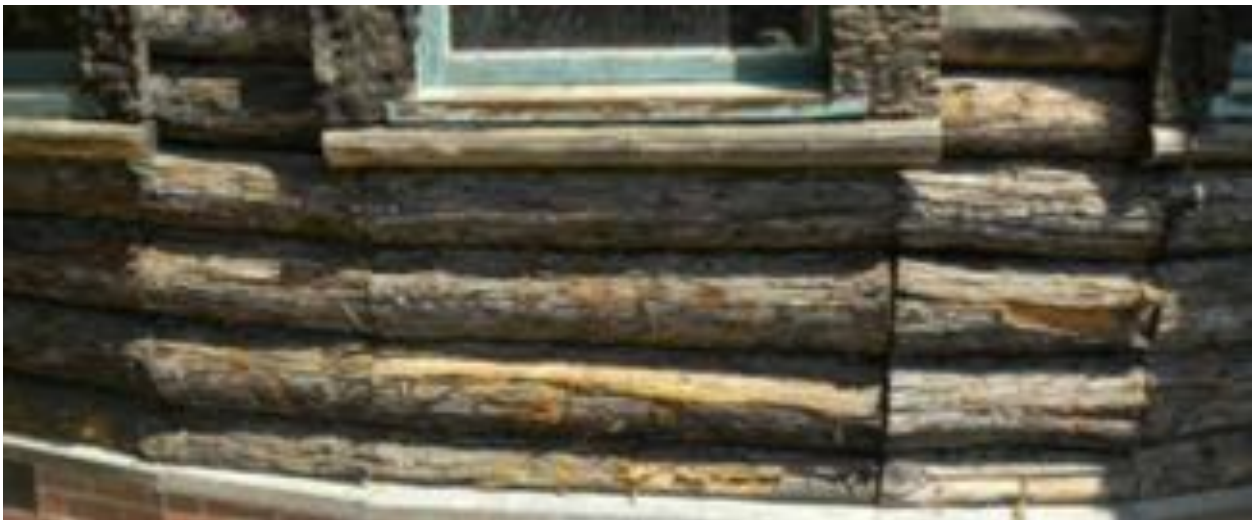
**Fig.44 – Log conditions at front wall**

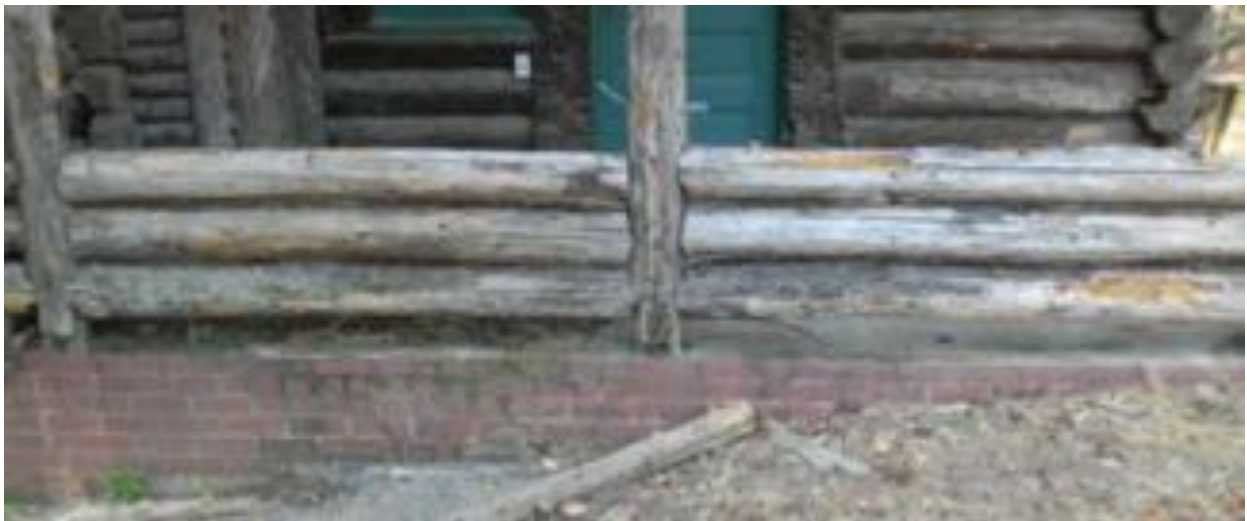
**Fig.45 – Log conditions at rear porch**

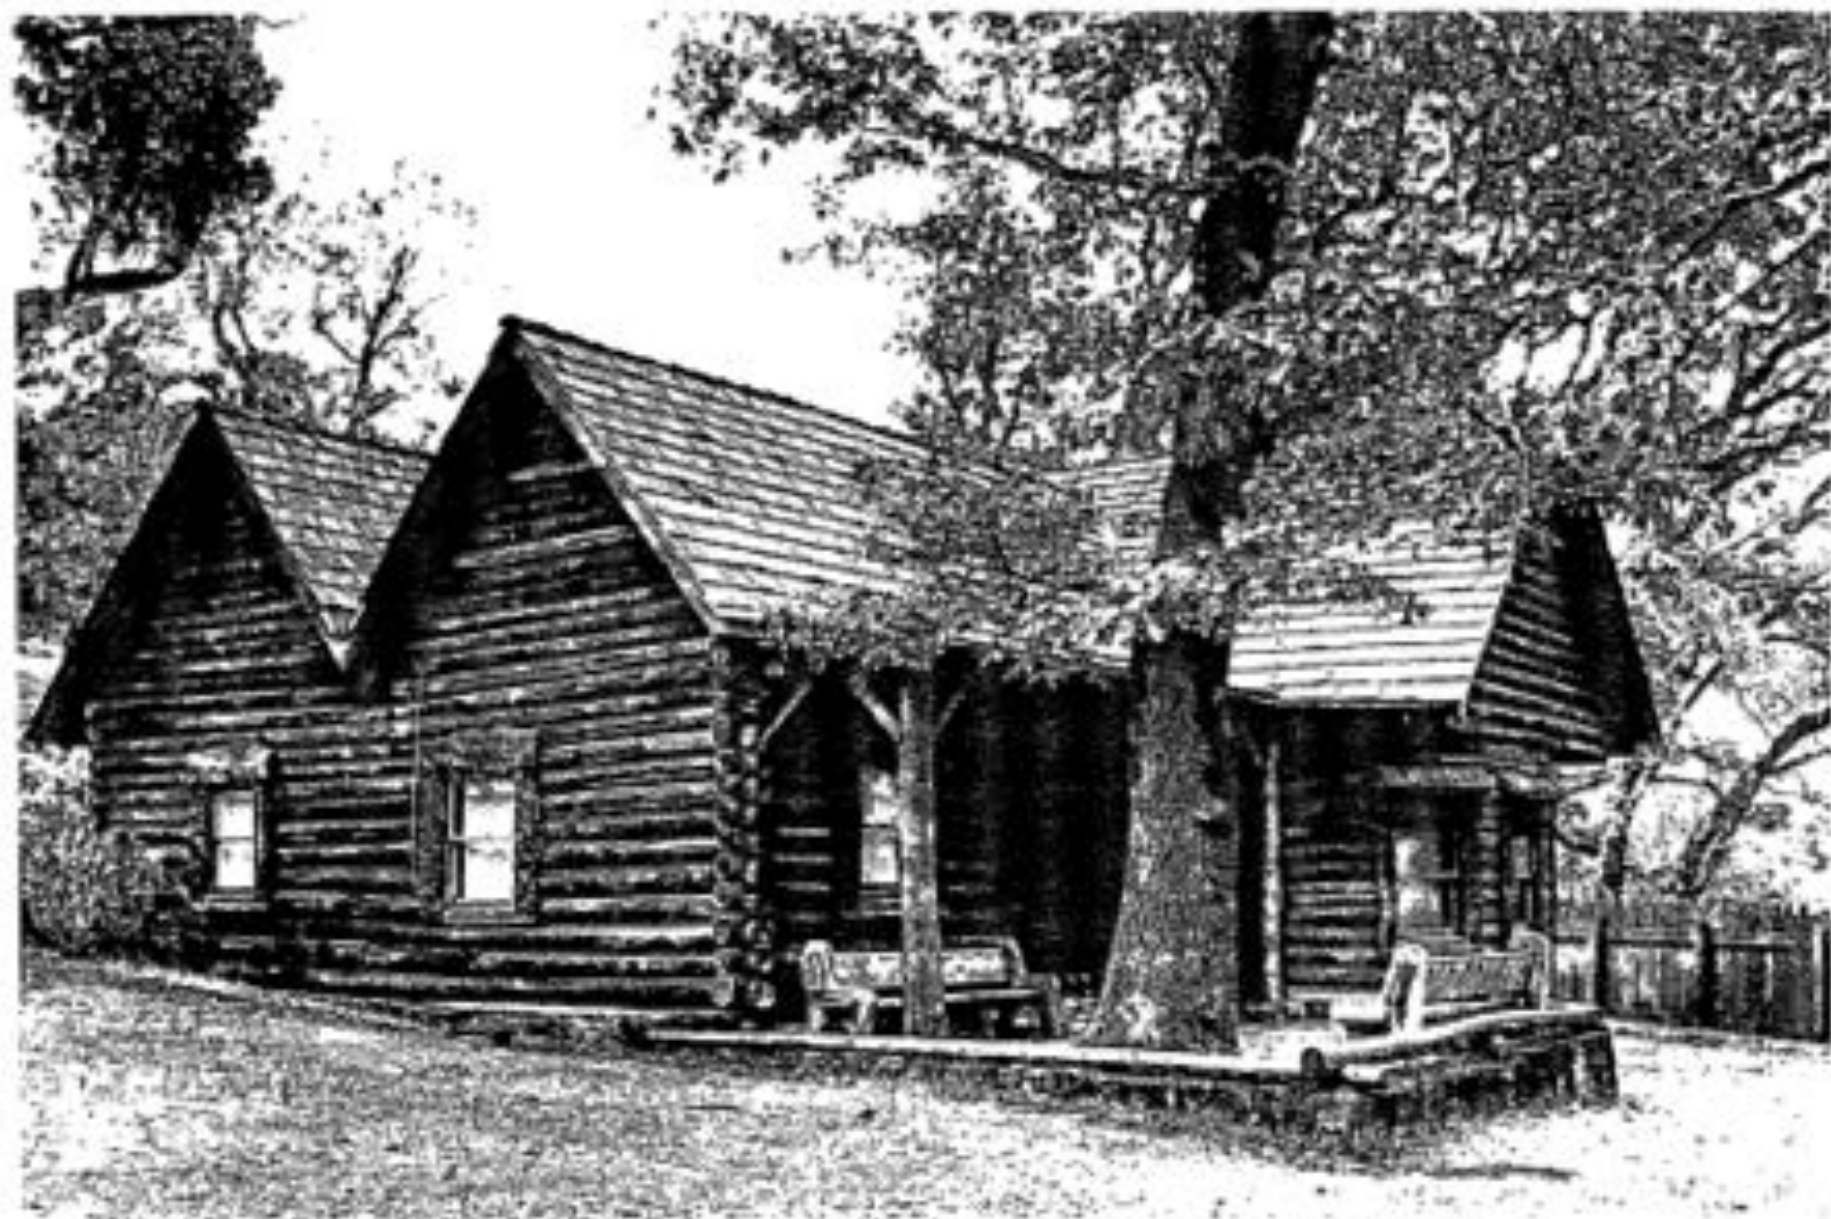
Southwest and northwest elevations looking east. Terrace is not original and the original wood porch (as seen in the c.1900 photograph) should be replaced.

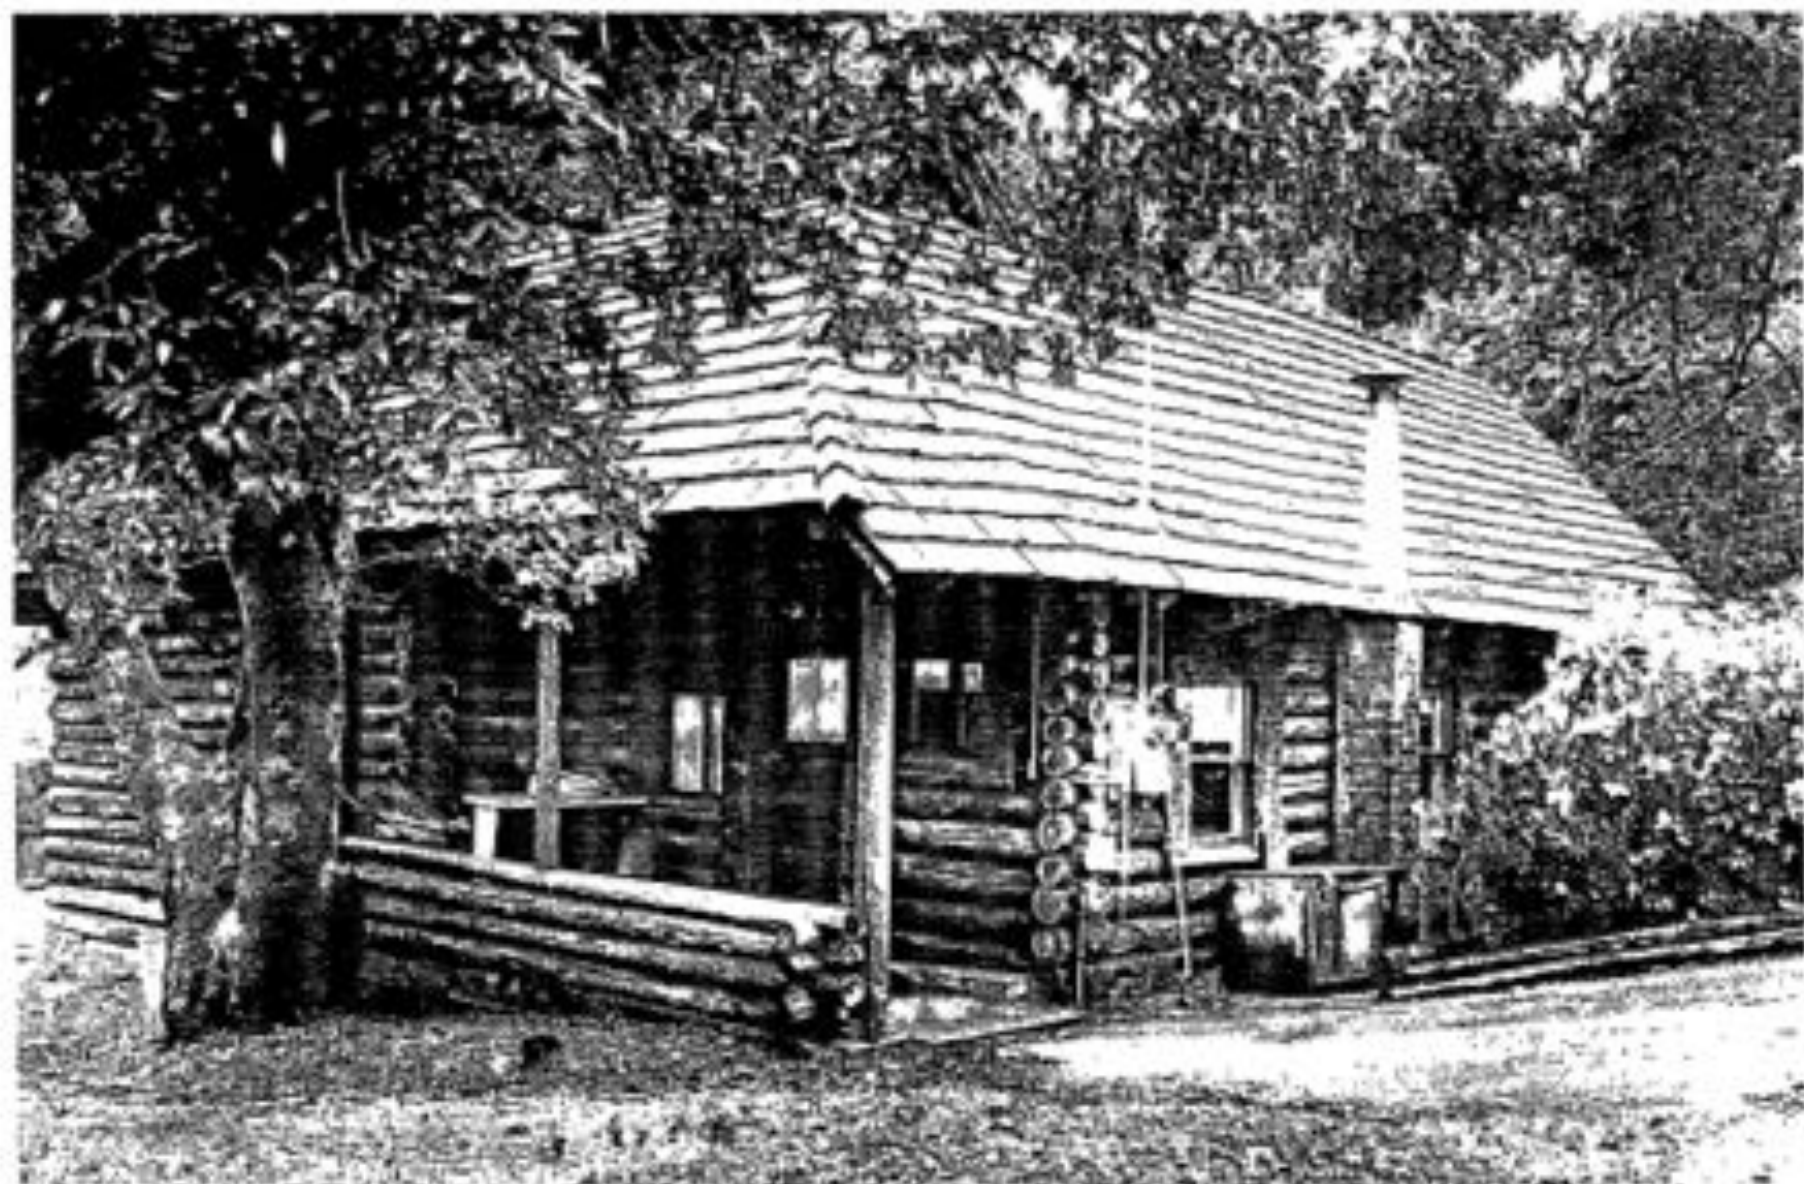
Northeast (rear) and southeast elevations looking west. Note unsightly electrical equipment and conduits--these should be relocated in a less conspicuous location.

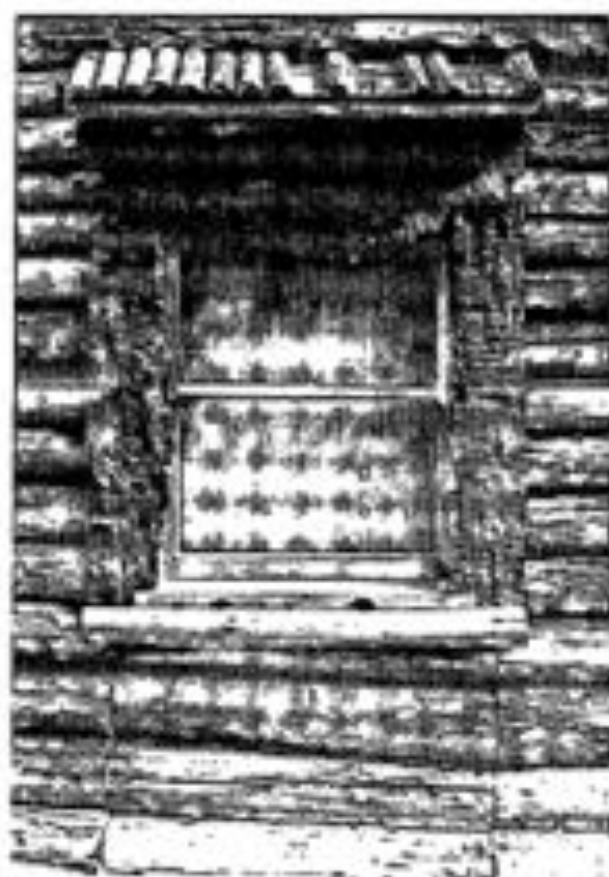
Views of typical exterior window sill damage.

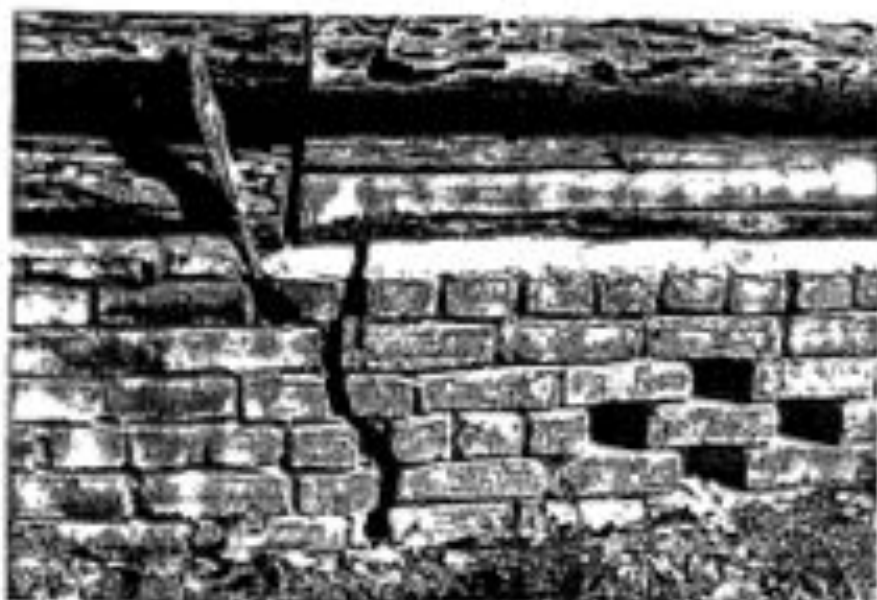
Various views of deteriorating logs with severe fungus and insect damage, resting upon cracked foundation walls.

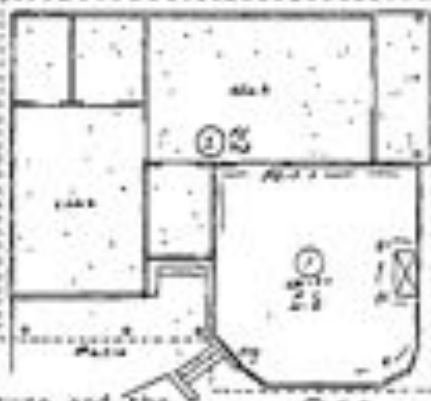
At the time of this inspection the wood floor had been removed, exposing the joist network and the interior of the perimeter foundation. Extensive structural damage was noted to the joist network from subterranean termites and a heavy wood boring beetle infestation. The area previous to opening was constructed on grade or in very close proximity to grade. A large percentage of the intermediate supports with the joist network were noted to extend into the unimproved soil. At the fireplace the form boards of the pedestal were noted intact, and fungus and subterranean termite infested. At the left forward portion of the living room, extensive decay fungus activity and damage was noted to the 1x4 wall sheathing from apparent moisture entry through the log stack at the exterior. Heavy dry wood termite excrement pellets were noted on the unimproved soil, sitting from the log configuration at the right front. Examination of the foundation at the right side of the structure and the forward most portion of the structure, heavy settlement cracks were noted in the brick mortar lines. On the left forward most portion of the structure, Cont.
