Bothin Marsh Geomorphology, Ecology, And Conservation Options

Chapter 3: Environmental History of Intertidal Habitats in Richardson Bay with Emphasis on Bothin Marsh

On behalf of
Marin County Open Space District

January 2018

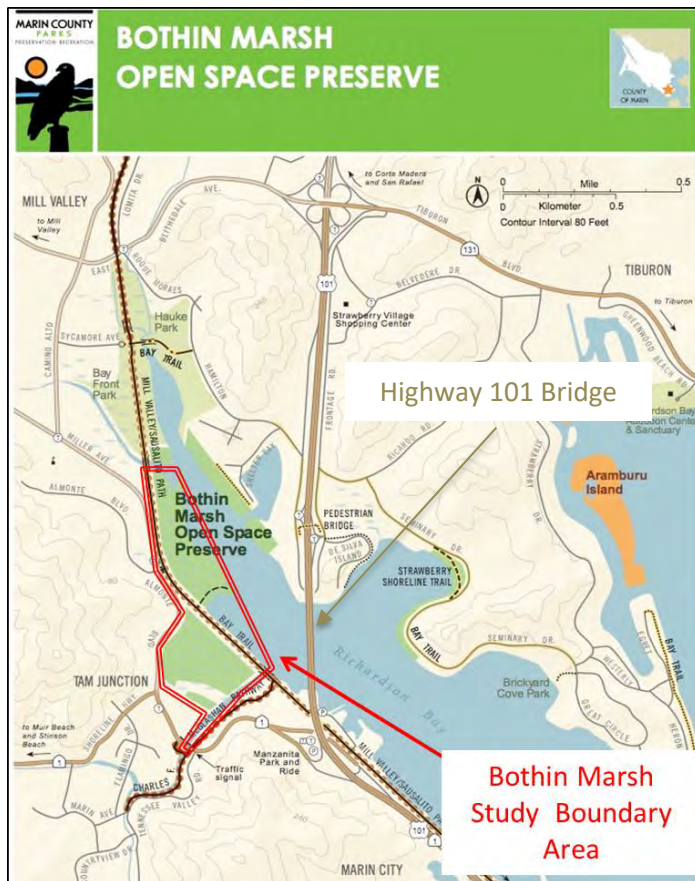
Figure 3.1. Location of Bothin Marsh Complex Study Area in upper Richardson Bay. Map courtesy of Marin County Open Space District.

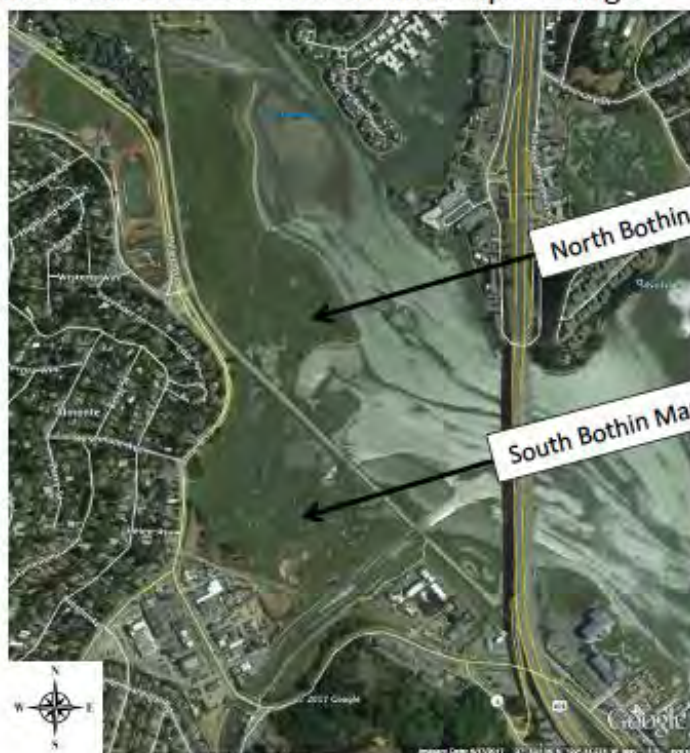
Ref
1

Location of Bothin Marsh Open Space Preserve is shown in green. The double red line shows the project area for modern tidal Bothin Marsh, the focus of this memorandum. The historical analysis extends beyond the boundaries of the project area to understand the context of landscape change

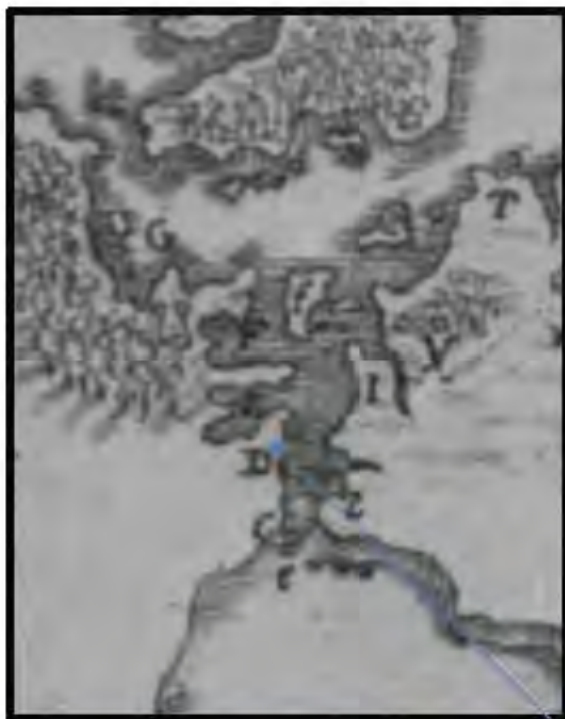
1781, Cañizares Map of San Francisco Bay

Possible embayment of Coyote Creek can be seen between the E and D symbols on the map.

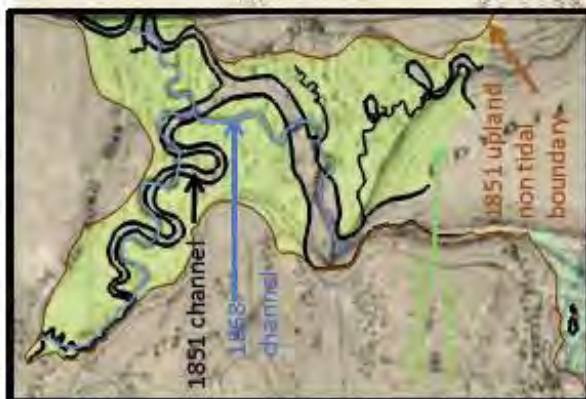
Ref
12

Detail showing comparison of 1868 channel position and sinuosity to 1851. Note the 1868 map appears to be a conceptualized channel and shoreline. A better survey was done in 1870 of the marsh shoreline. The 1851 marsh boundary is shown in green with the brown line representing the upland non-tidal boundary.

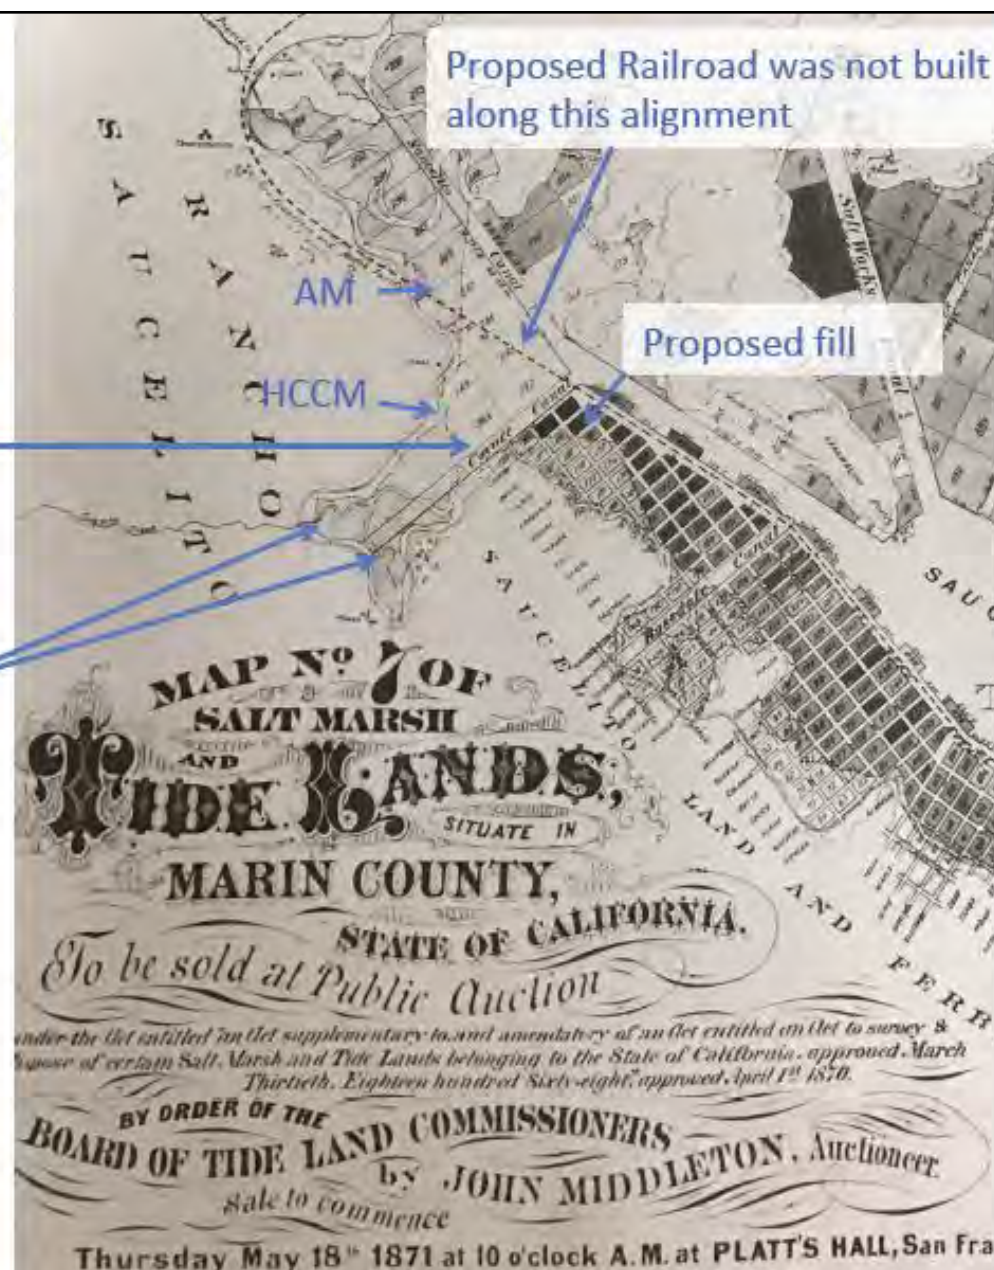
Ref
14

May 1870, No. 7 Salt Marsh and Tidelands Sales Map,

The San Rafael Road otherwise
follows the perimeter of the
marsh. About 10.6 ac marsh
eliminated. Greater creek detail
is mapped in other 1870 maps
(Image Ref #14, #15 & #16).

<p>The 1870 map (Image Ref #15, #16, and #17) indicates that ~10.5 acres of marsh at the upstream end near the transition of Coyote Creek into the marsh was eliminated and that the San Rafael Road generally followed the perimeter of the marsh except for cutting off a landward portion of the marsh. This would have reduced tidal prism in the Coyote Creek Marsh, which would have initiated narrowing of the tidal marsh channels. Tidal prism is the volume of tidal flow moving in and out of a bay or tidal channel. A reduction in the tidal prism of a marsh causes its tidal channels to shoal and narrow because they have less volume of tide flow to convey. A shoaling or narrowing of tidal channels is therefore evidence of reductions in tidal prism. The road crossing at Tennessee and Coyote Creeks probably influenced the ability of the creeks to convey their sediment loads downstream. Whether these were bridges or fords are unknown. This map is considered to be a more reliable depiction of the upland MHHW boundary than the 1868 tidelands map, particularly since it indicates survey points along the marsh perimeter. However, the reliability of the depictions of Coyote and Tennessee Creeks above their confluence is uncertain. The map shows that houses existed upstream of the southwest corner of the Coyote Creek Marsh along Tennessee Creek and at the north hillslope between Coyote Creek and Almonte Marshes. Cattle ranching and/or crop farming were likely causing increases in sediment supply to the marshes, which supports the indications of increased sedimentation in Richardson's Bay.</p> <p>The tidal reach of Coyote Creek downstream of its confluence with Tennessee Creek shows substantial decrease in width, since early 1850s. The same is true of Arroyo Corte Madera del Presidio along northern edge of Almonte Marsh. For example, at the site equivalent to where Flamingo Road currently crossed Coyote Creek, the channel width in 1851 was roughly 125 ft. The 1870 map indicates that it narrowed to roughly 80 ft. These changes in channel width reflect the reduction in tidal prism due to marsh reclamation and road crossings. Similar changes in channel width are evident for the Arroyo Corte Madera del Presidio watershed.</p> <p>The 1870 map indicates a significant difference in the planform of tidal reaches of both Coyote and Tennessee creeks upstream of their confluence. Image Ref #16 shows a detail of Tennessee and Coyote Creeks. Image Ref #17 and #18 show comparisons of channel position during and prior to 1870. By 1870, the Coyote Creek channel had been truncated where the 10.5 ac of marsh had been reclaimed. The cause of this reclamation is not known. It may have involved diking, filling, or a combination of both. The San Rafael Road was likely on an elevated berm but it is upstream of the truncated marsh.</p>

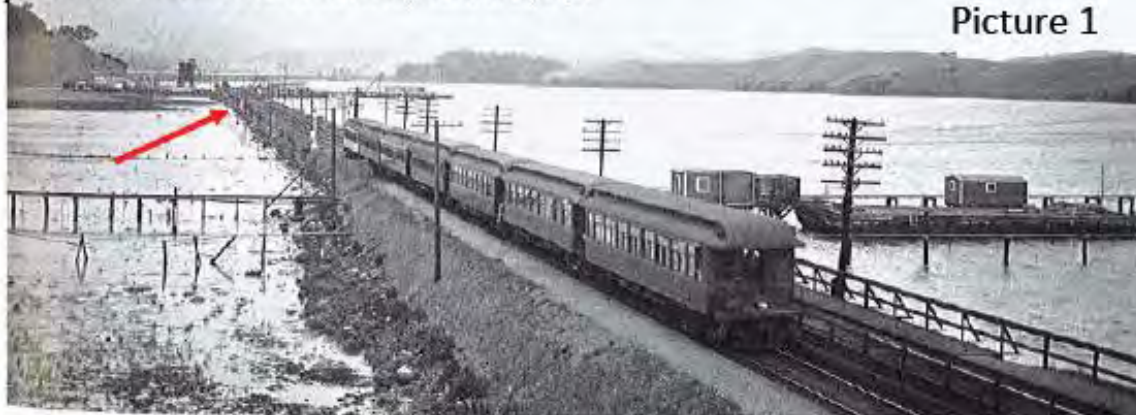
Picture 1

Undated photographs “1 and 2” from Garcia and Associates Letter of 12 December 2016 that misidentifies this area as Coyote Marsh. Source: Garcia Assoc., Memo of 12/16/16

Upper photo is looking northward from Sausalito at a RR levee along Sausalito south of Bothin Marsh. It looks like the drawbridge of the Redwood Bridge of Hwy 1 can be seen in the distant background. Note how high the RR levee is with new fill for the double track. By 2017 in Bothin Marsh sediment has filled substantially to a greater height along both sides of the RR. The red arrow is presumed to be pointing at an outlet beneath the tracks.

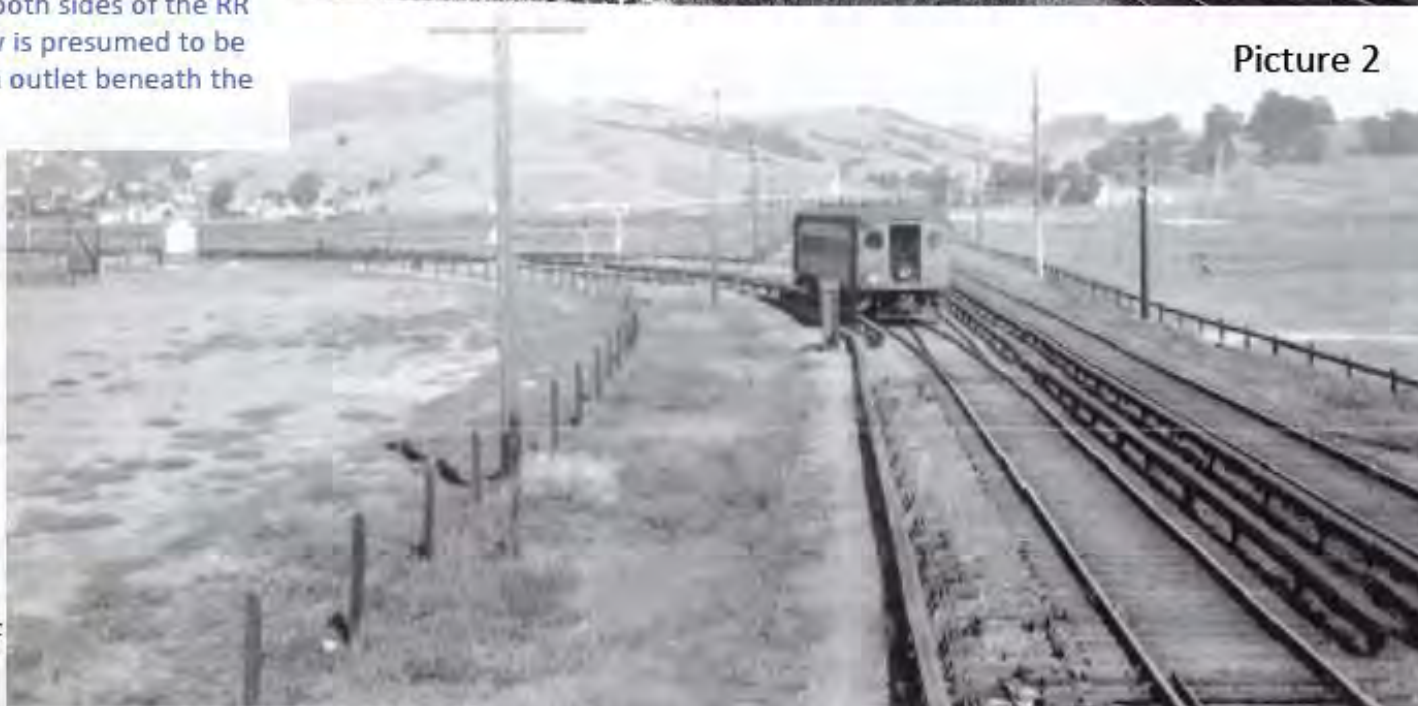
The lower photo shows Almonte Marsh to either side of the tracks while looking northward where the Mill Valley branch splits from the San

Circa 1898, looking northward along the Mill Valley branch of the NWPRR just beyond the intersection with the San Rafael branch that veers eastward and future Tam Valley High School location, which would be to the southwest. All portions of the tidal marshlands in this photo are bounded and influenced by an altered tidal prism from the railroad berms.

Picture 2 of Image Ref #35 shows the junction of the Mill Valley and San Rafael rail lines along Almonte Marsh. The marsh along the west side of the Mill Valley branch appears dryer, perhaps due to the muted tides caused by the Railroad levee constructed along the eastern foreshore of the marsh in 1883.
1898	36, 37		<p>The Mill Valley Branch of the rail line pictured in Image Ref #36 was taken in 1898 and shows sparse development in the background hills. It seems likely that the previous undated picture 2 photo of Image Ref #35 post-dates Image Ref #36 because it shows much more hillside development. The Mill Valley branch further dissected Almonte Marsh, restricting tidal flow to the marshlands on the western side of the tracks to small culverts beneath the railroad levee. This further reduction in tidal prism and resulting poor drainage caused the former channels on the west side of the tracks to become pannes or potholes. Much of the marsh vegetation in the backshores of Almonte Marsh during this time appears to be dominated by pickleweed or other low-growing, salt-tolerant vegetation.</p> <p>Image Ref #37 shows what appears to be a narrow channel in the mudflats connected to the inlet to the Coyote Creek Embayment at the recently shortened trestle. This image also shows an area of light shading at the flatlands between Coyote Creek and Tennessee Creek. The shading is consistent with reflection off standing water. The area may be ponded due to flooding or irrigation. The tides are low in this image, suggesting that any flooding upstream is not tidal.</p> <p>The abandoned 4000-ft-long railroad trestle across Richardson's Bay between Strawberry Point and Sausalito can be seen very faintly in the background of Image Ref #37.</p>

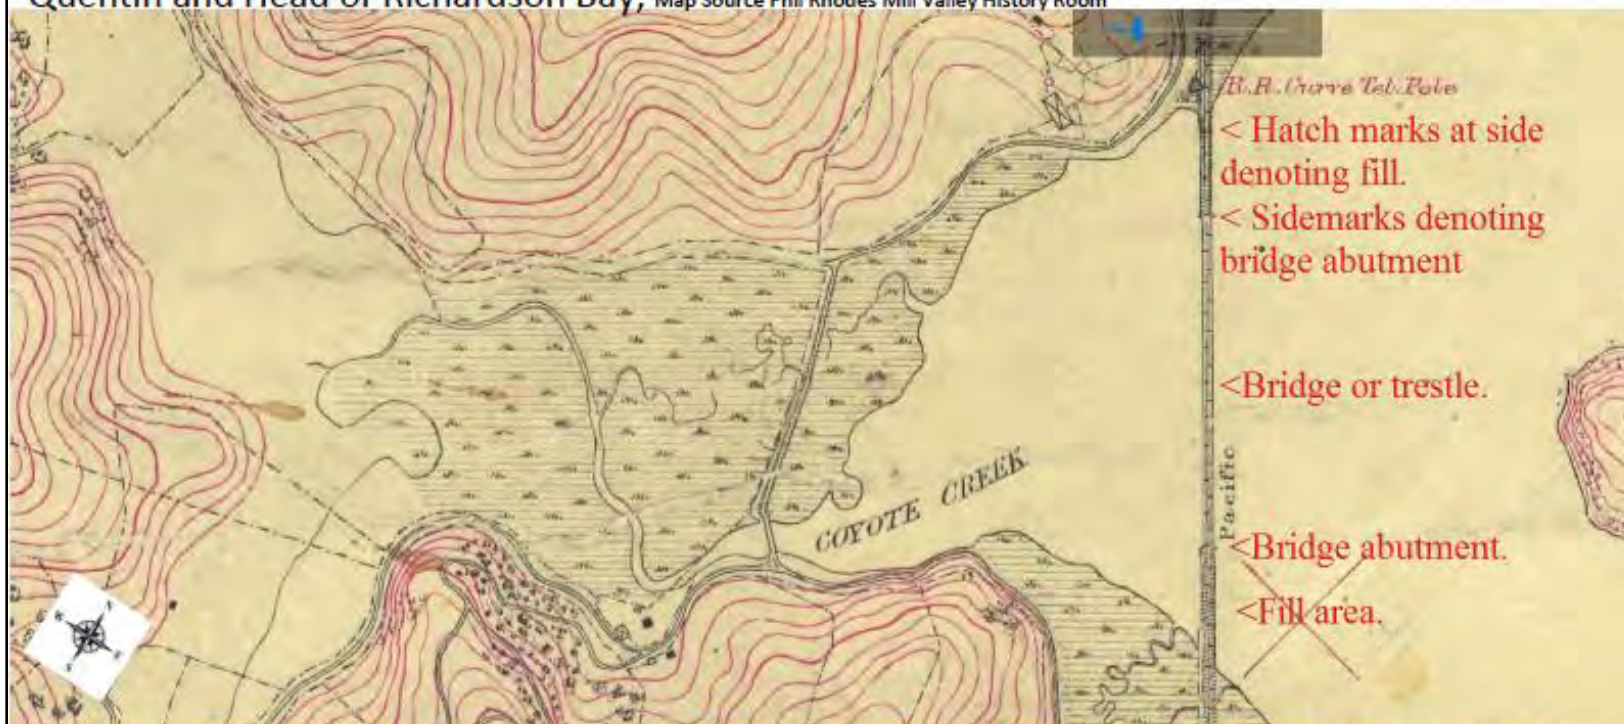
1899, Detail of T-sheet 02485 USCGS, San Francisco Bay, California, City Point to Point San Quentin and Head of Richardson Bay, Map Source Phil Rhodes Mill Valley History Room

Railroad trestle is here depicted in detail. Outside hatch marks typically denote fill. Bridge abutments are denoted with curving outside lines that bend away from the span. These are clearly evident on this map. While there is no certainty this 1899 map is entirely correct in its depiction of the rail line here, Rhodes (Mill Valley Library History Room) considers it unlikely that the surveyor and drafter of this map would have gotten such key details on a waterway wrong. Source: 1899 T-sheet from P. Rhodes, email 4/25/2017. Historians from the NWPRR Society state that the trestle was replaced with a berm in 1894 (verbal communication to L. Collins). This seems consistent with information developed for this report. The length of the original trestle over the Coyote Creek Embayment appears to have been about 1310 feet long while the total amount of berm extending across the bay from the 1899 shoreline to the trestle was about 850 feet.

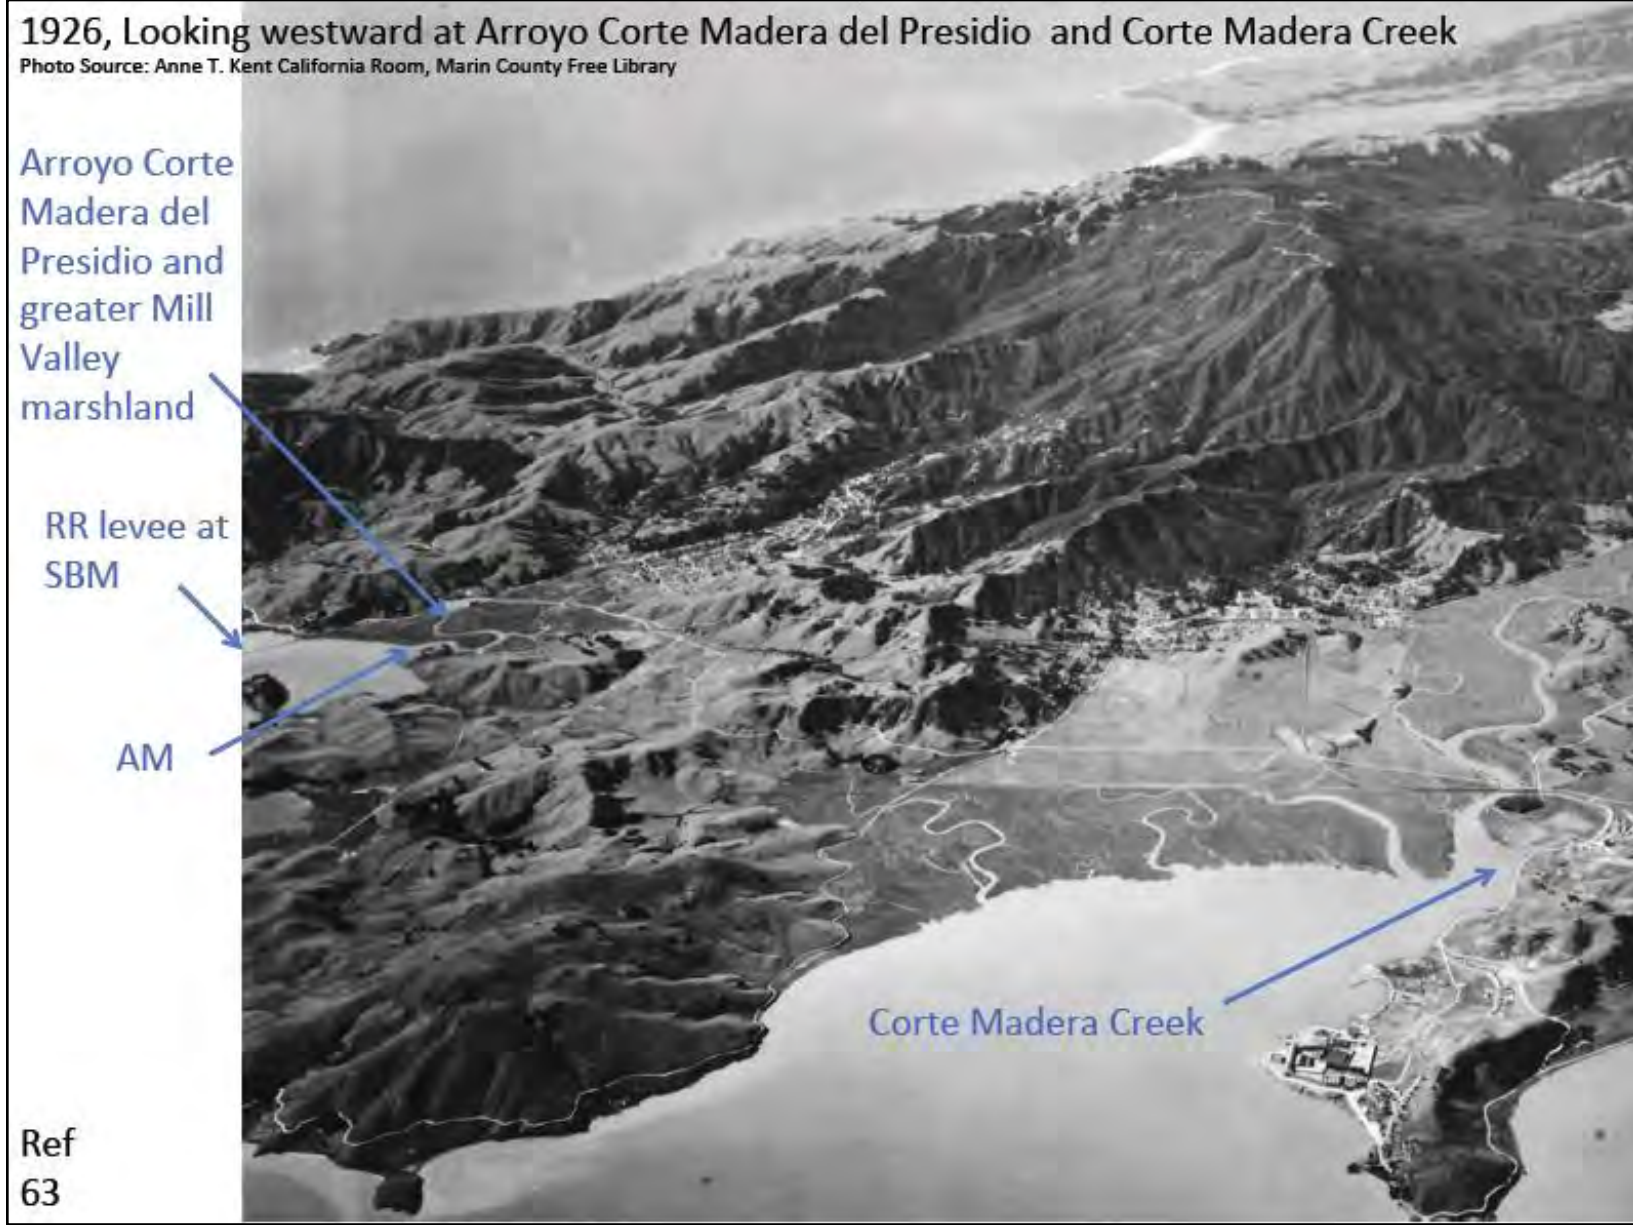
1927, US Coast and
Geodetic Survey,
Planimetric Map T-sheet
5929 overlaid onto 8/2016

Google Earth Imagery

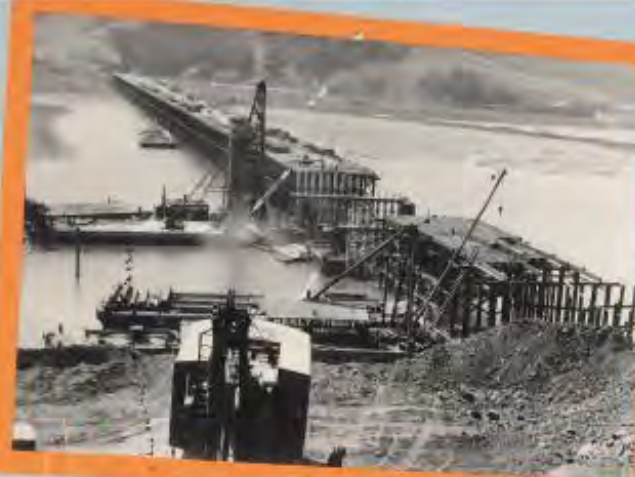
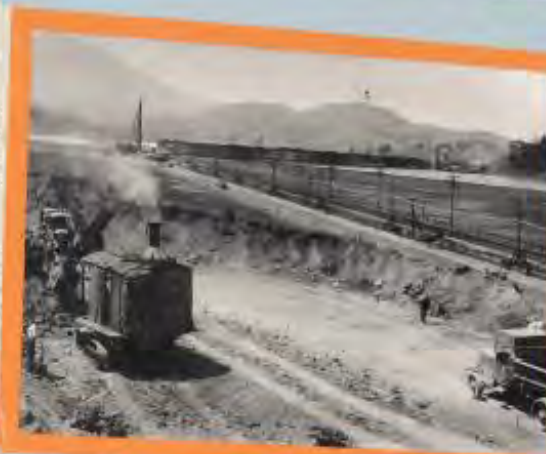
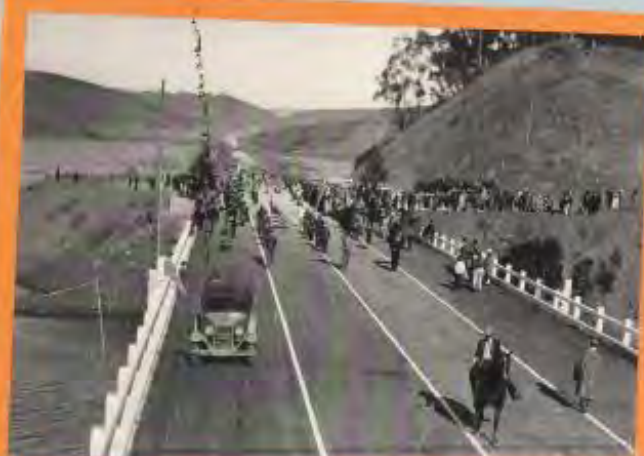
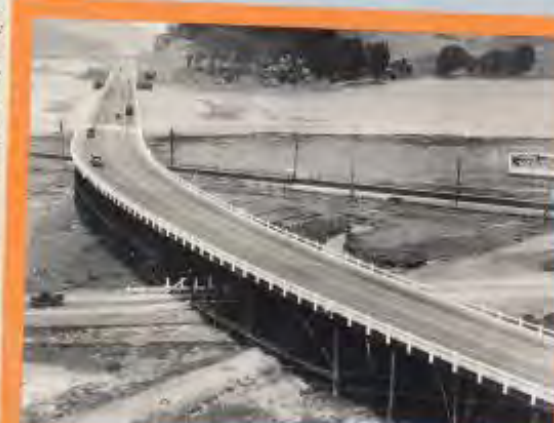
Ref
69

The Richardson Bay Redwood Bridge

The Richardson Bay Bridge, as seen today, was constructed of concrete in 1956, and received extensive seismic retrofitting in 1996. Prior to the present day bridge, an earlier version stood in its place.

The original Richardson Bay Bridge was made entirely of redwood and was therefore named the "Redwood Bridge." Over two million board feet of lumber was used in the construction of the 2,477-foot structure. The lift section near the northern edge of the bridge provided a 40-foot clear channel to access the bay west of the bridge. Since the west side of the bridge is only navigable at high tide by small craft, it was seldom entered. During the 18 year period from 1931-1949, the span opened only six times.

The Northwestern Pacific Railroad, a narrow-gauge line that ran from Sausalito to Cazadero, via Larkspur, San Anselmo, and Point Reyes Station, crossed beneath the southern end of the bridge. Today a portion of that railroad right of way has been converted to the bike path on which you are now traveling.

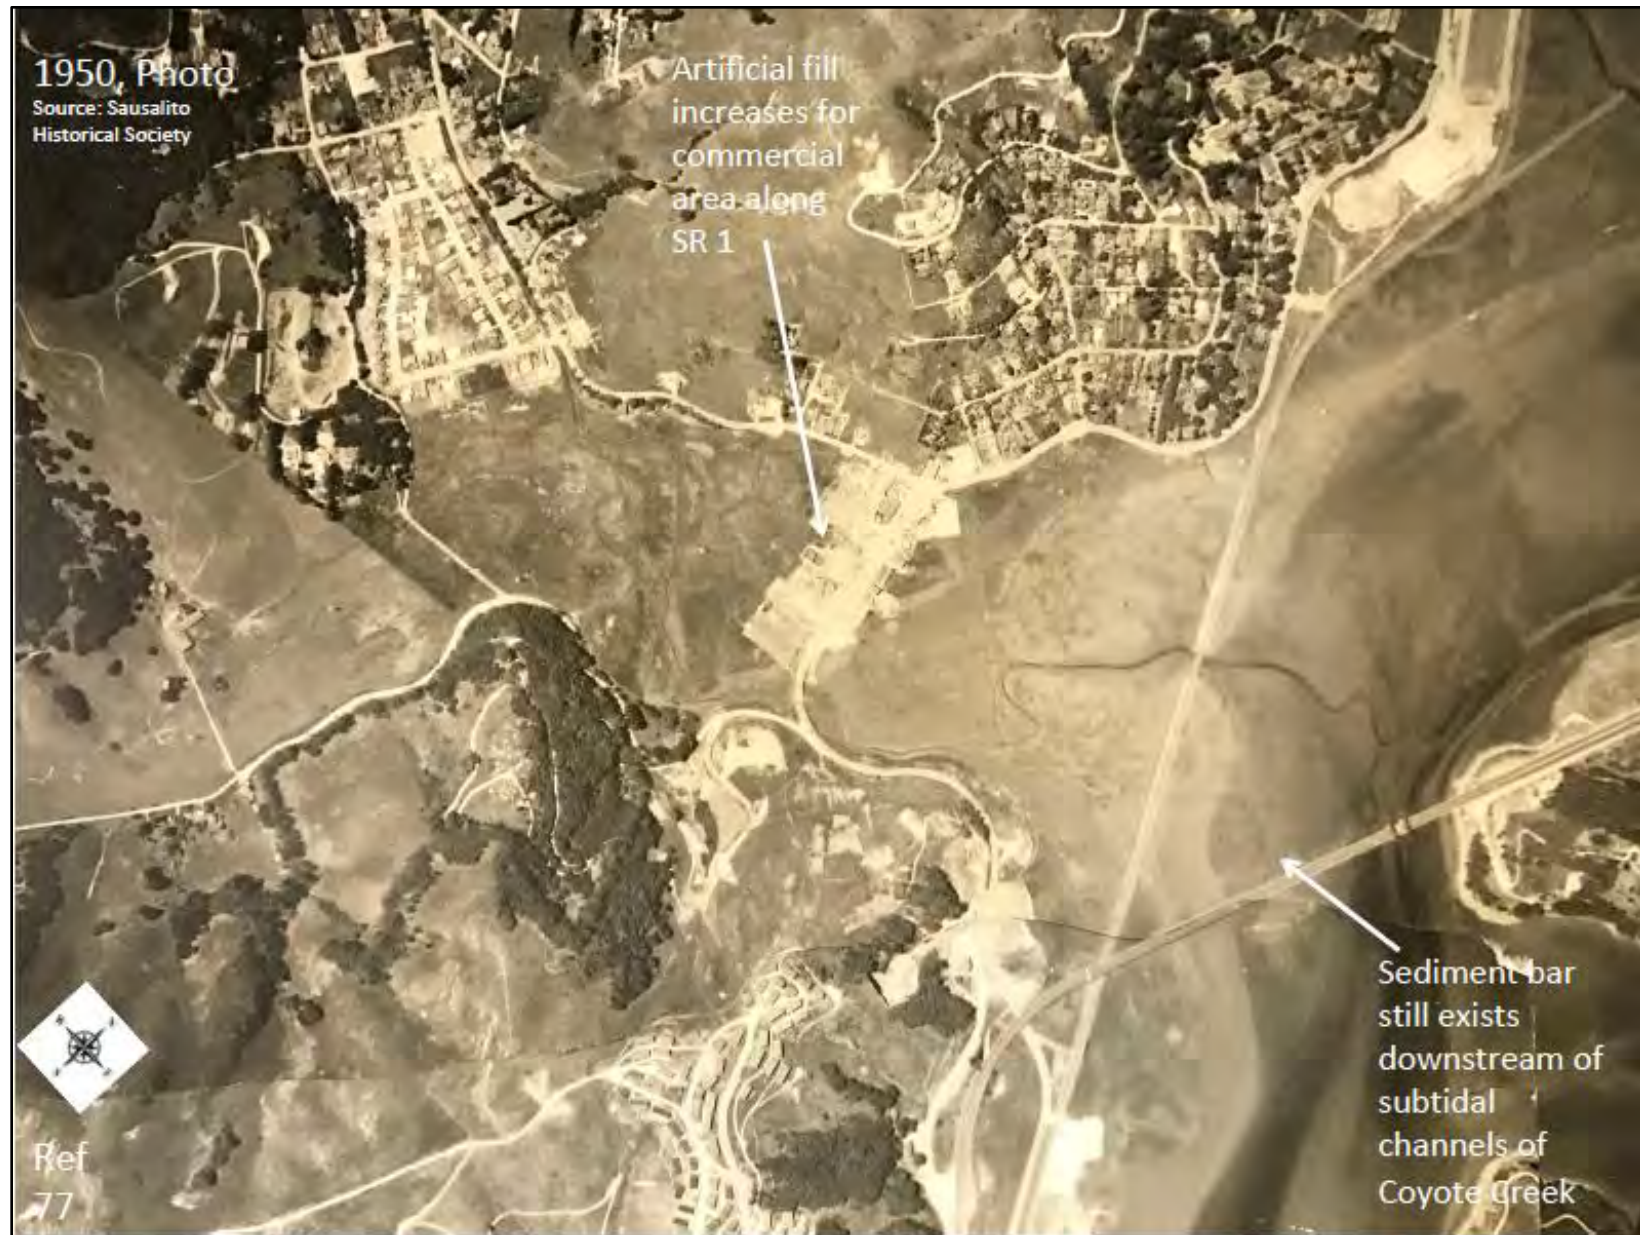
Ref
78

1950, Looking
southeastward at
Redwood Highway
Bridge crossing
Richardson Bay

This later c. 1931 sports field is constructed to south of the earlier 1923 track. Artificial fill has been placed over much of the former Almonte Marsh on the west side of Mill Valley RR branch and in the small triangle between the two branches.

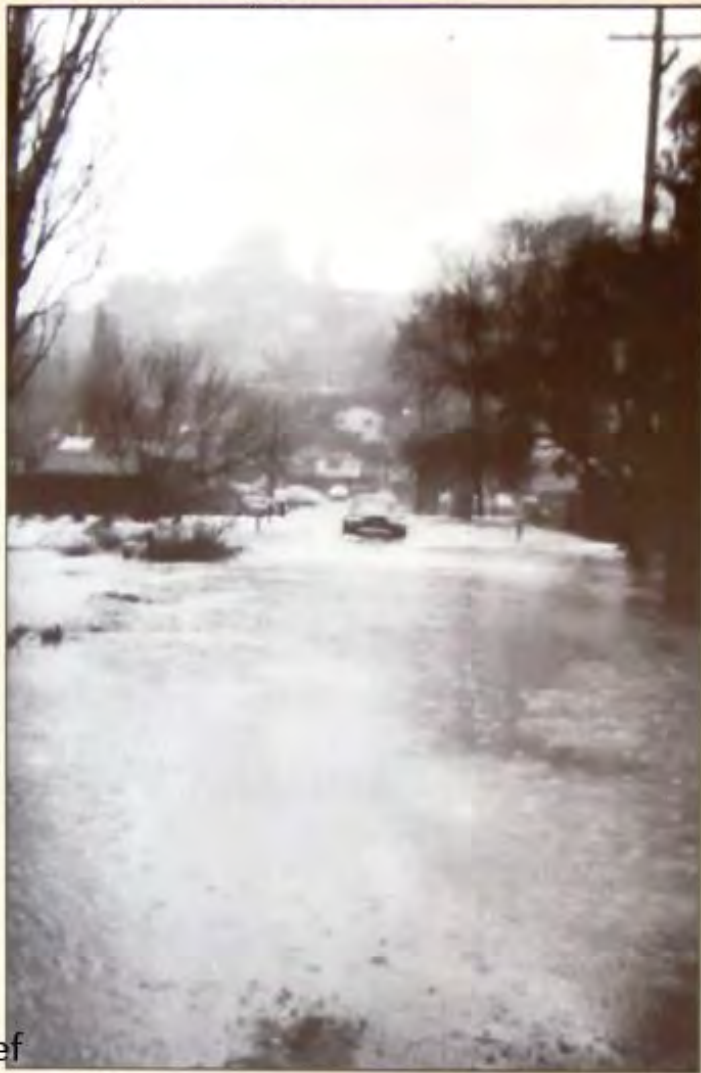
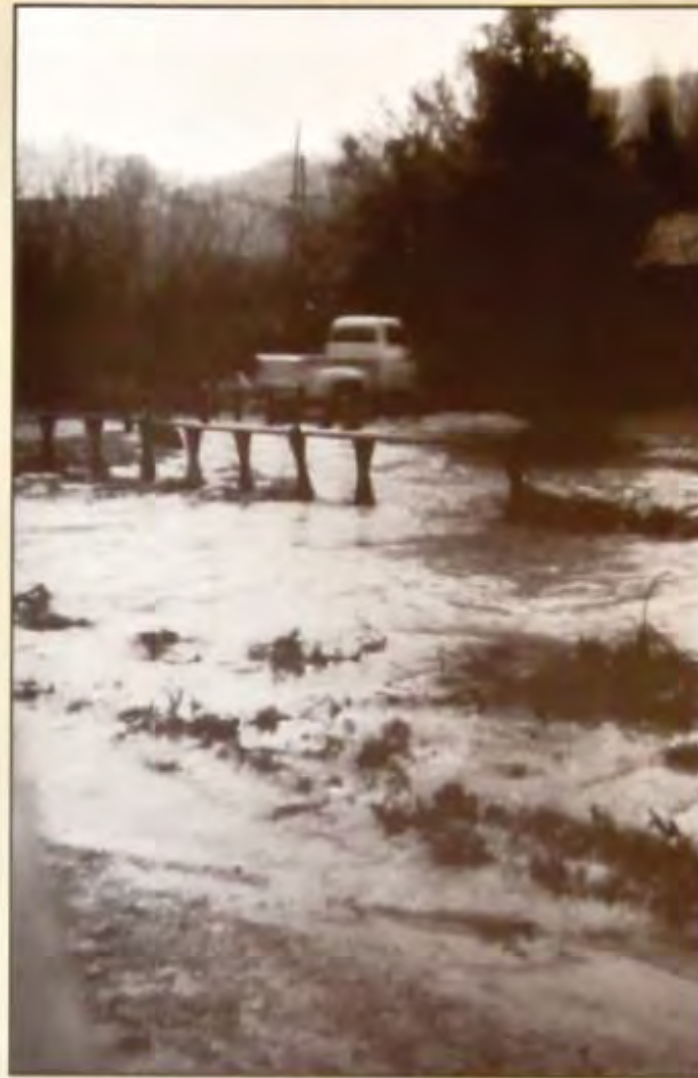
MAIN ST. (LAUREL) TOWARDS SHORELINE

SHORELINE BETWEEN PINE & SPRUCE

1956 Flooding

Dec 1955	82 83	Significant flooding throughout the Bay Area due to intense rain	<p>Flood at Arroyo Corte Madera del Presidio was caused by 9 inches of rainfall over the watershed that resulted in a peak discharge of 1400 cfs at the Camino Alto Bridge (USACE 1968). Flooding was widespread and ultimately led to the start of many flood control projects that straightened and diverted channels throughout Marin County.</p>

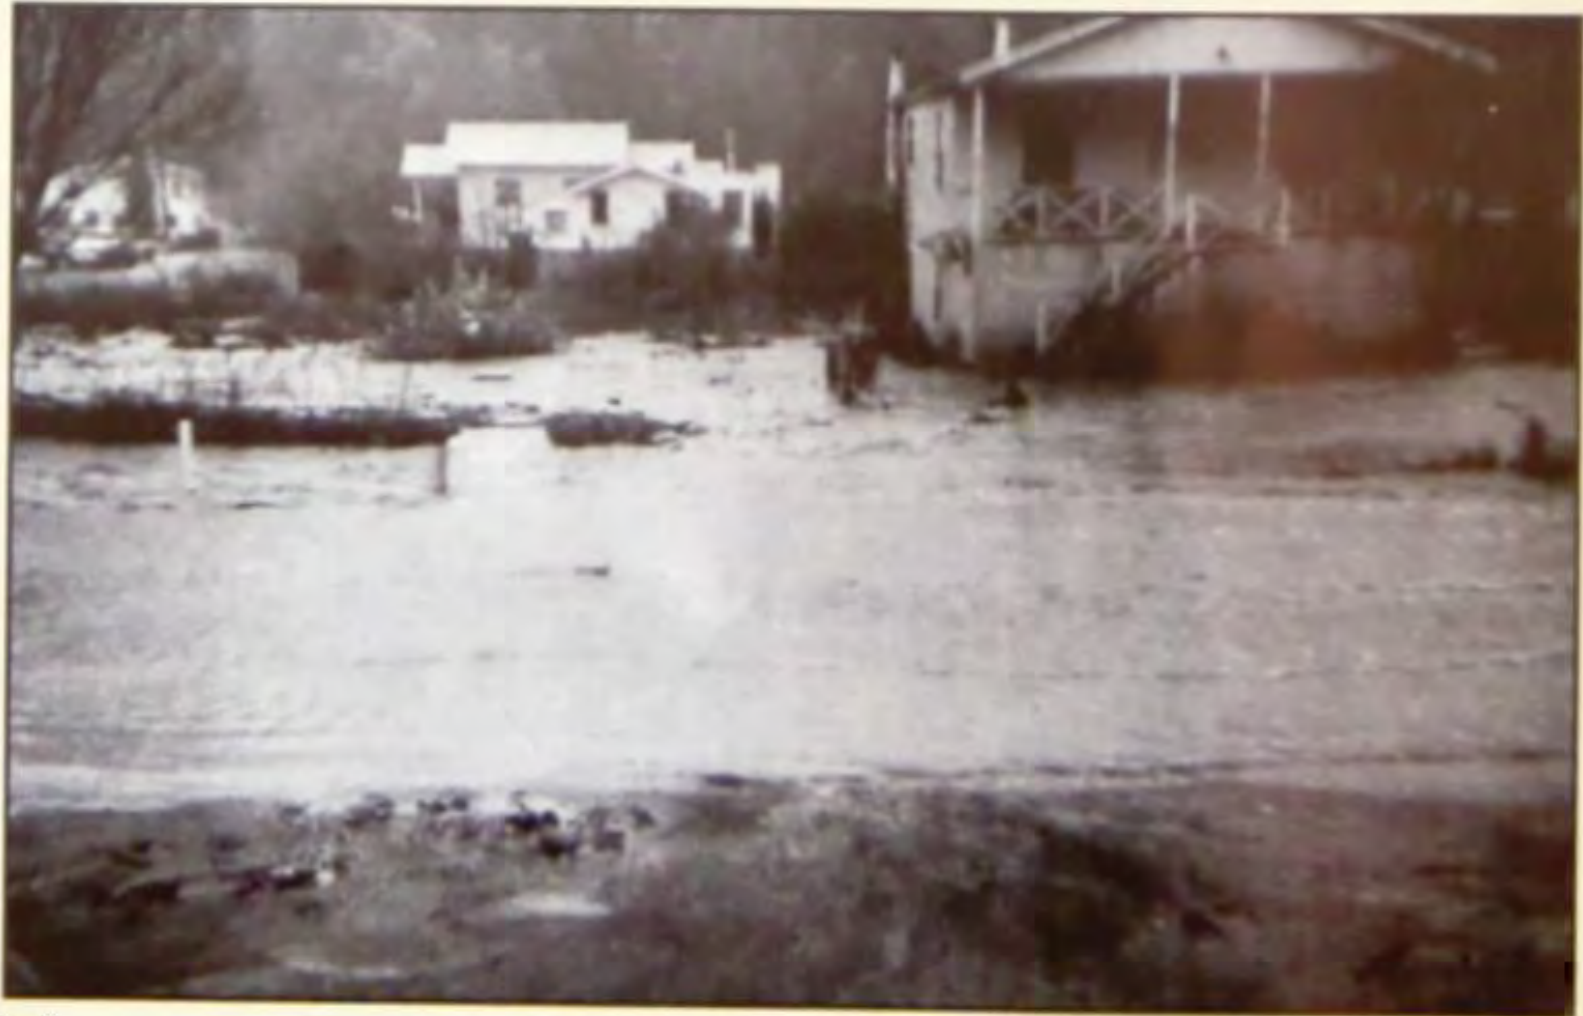
Ref
83

SHORELINE BETWEEN POPLAR & PINE ST.

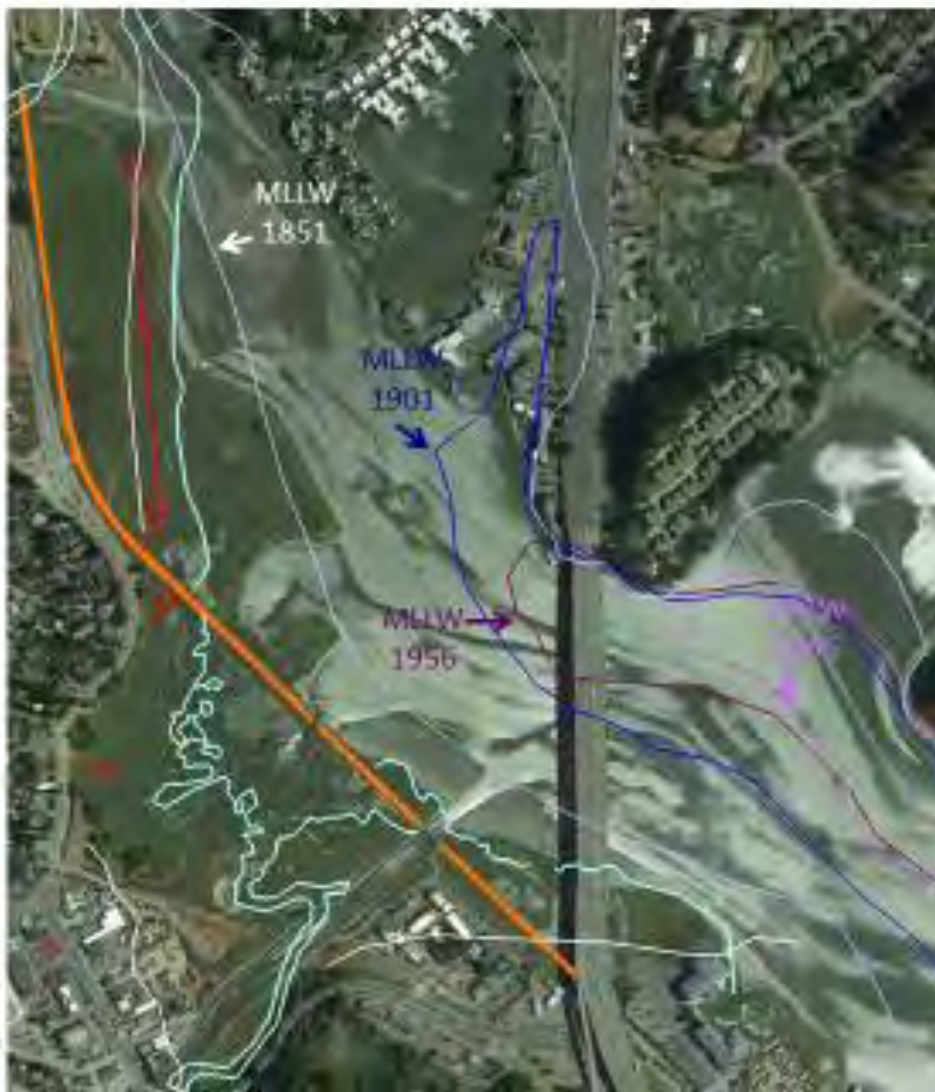
Bathymetric MLLW Boundaries from San Francisco Entrance, U.S. Coast Survey Charts #5532 Projected onto 6/2017 Google Earth Imagery

This map shows the changing conditions of the MLLW boundary. It shows that following 1851 (light lavender line) sedimentation in the bay pushed the 1856 boundary significantly southward (violet line). This might have been related to the influx of hydraulic mining sediment from the Sierra and local logging and ranching activities. By 1901 the shallow bay deepens northward (navy blue line), but by 1956 it shallows again, nearly approaching the 1856 boundary of MLLW. The latter period of shallowing might relate to loss of tidal prism from marsh reclamation and bay filling, as well as increased sediment supply from grading for urban development, channel diversion and channelization, and 1956 record flooding.

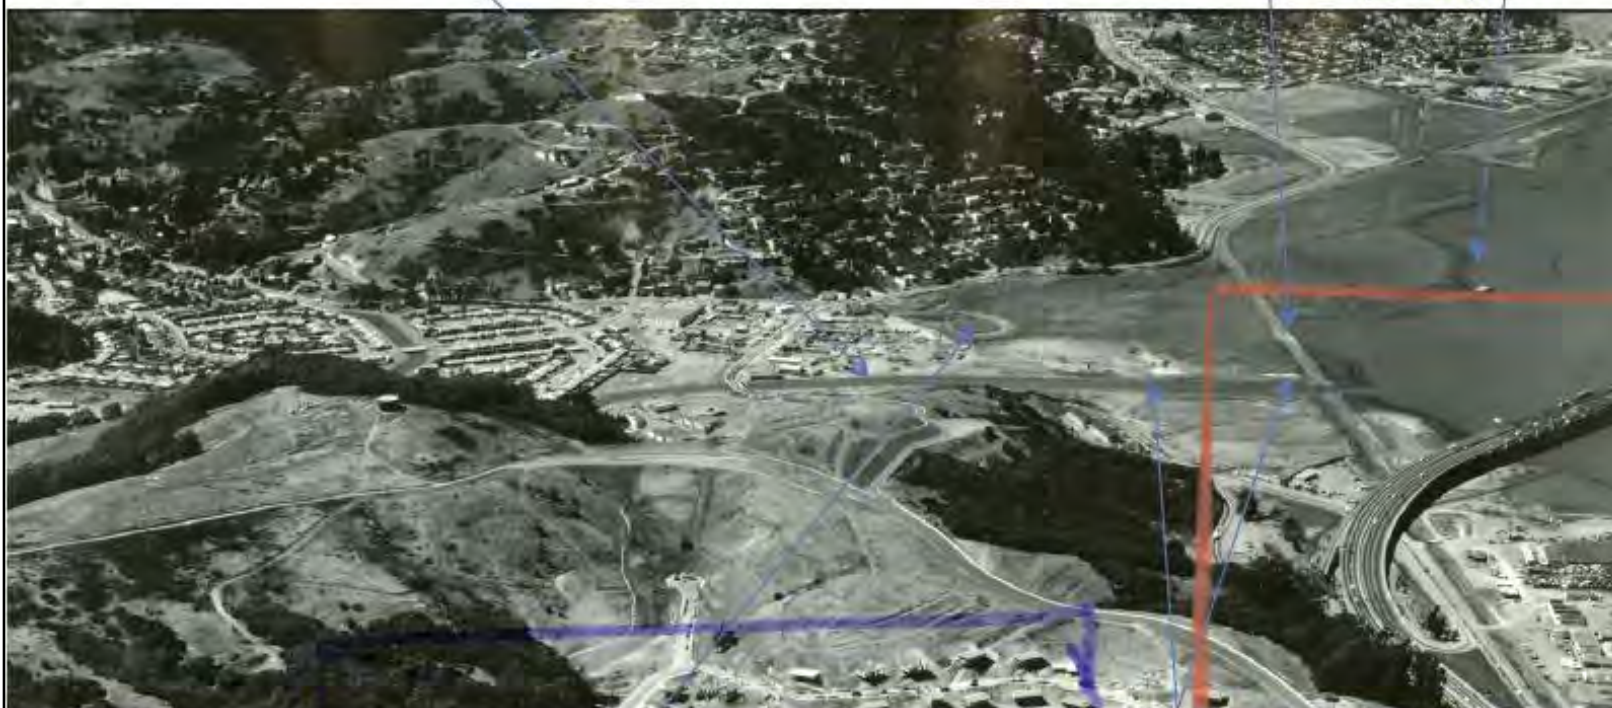
Ref
92

Artificial fill placed for narrowing the opening of Coyote Creek Embayment

New interior containment cell levee under construction (dredge in picture).

Artificial fill placed c. 1961?

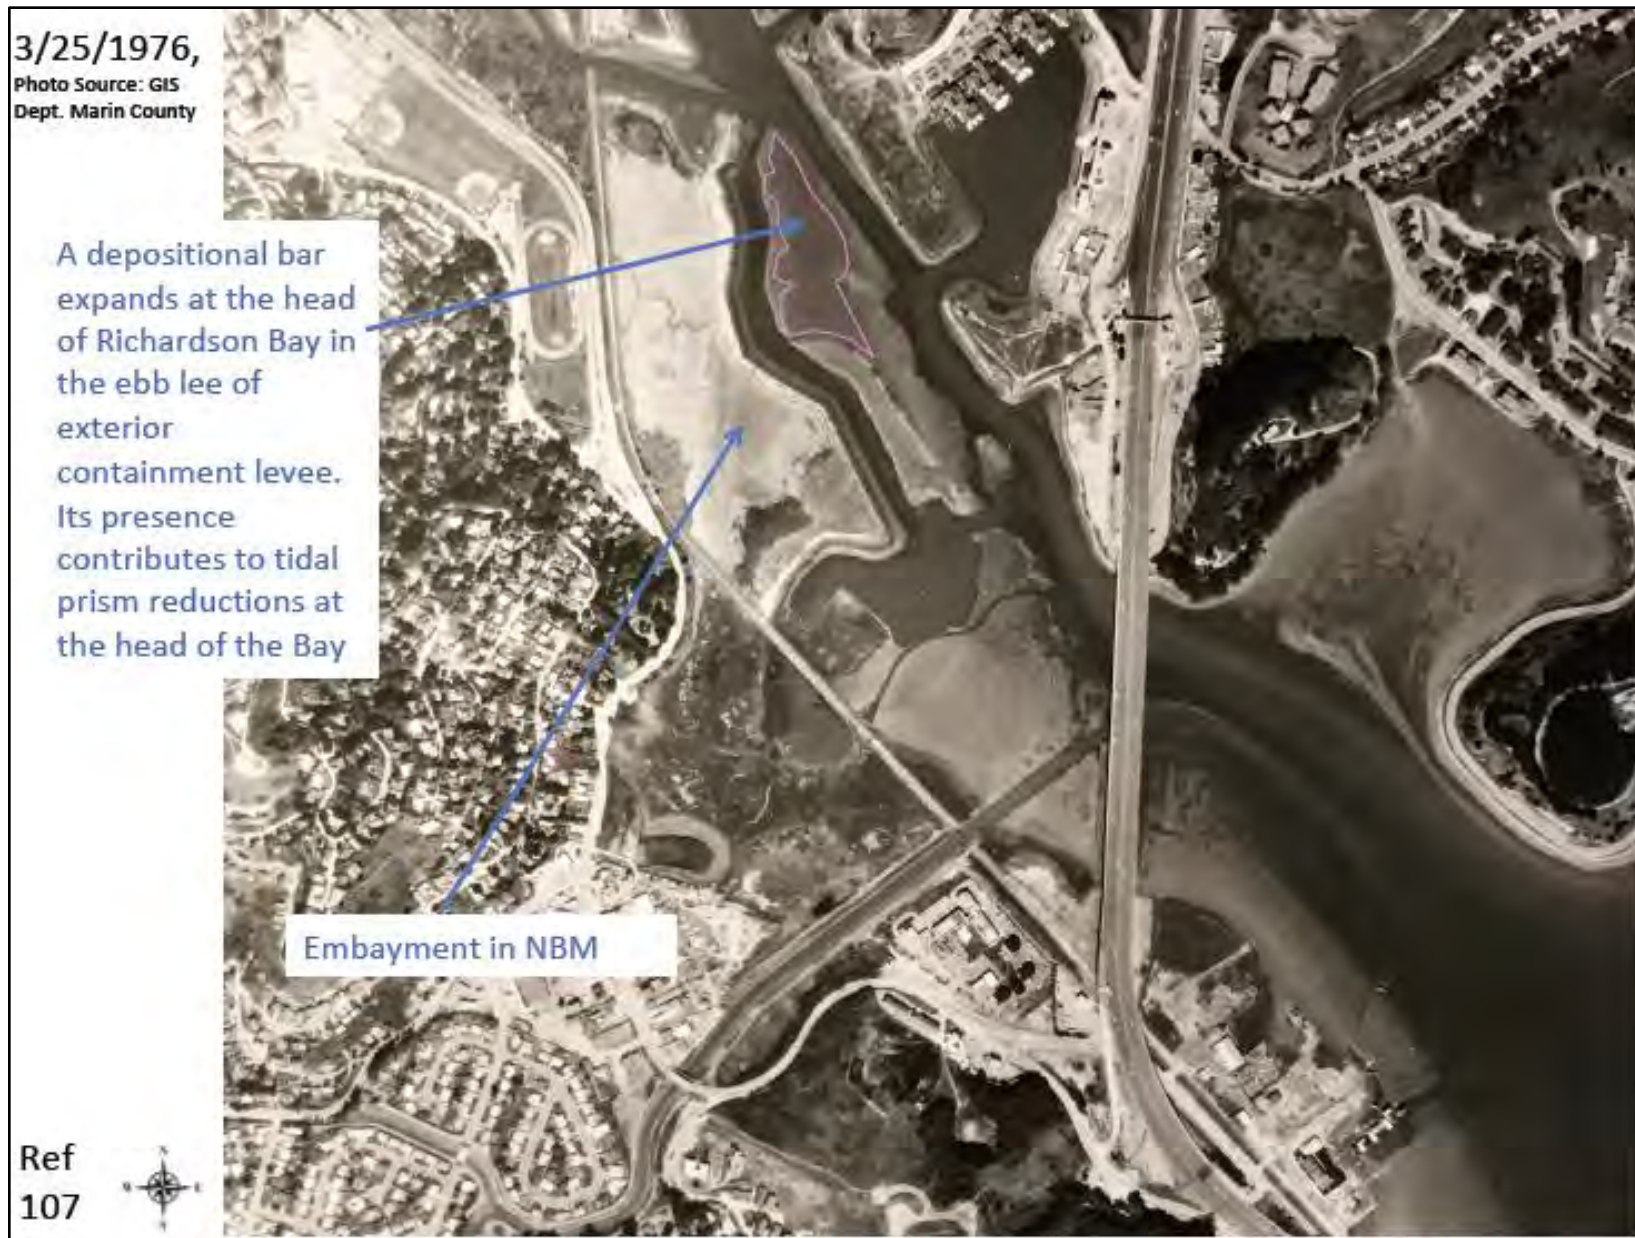
1976, Size of marsh segments mapped onto 3/25/1976 aerial photo

High marsh forming NBM on dredge spoils that were placed on former mudflats of Richardson Bay. NBM ~14.0 ac (4.4 ac subject to desiccation, ~1.7 ac inner bay, ~4.9 vegetated, ~2.1 ac Rectangle Marsh, ~0.9 ac outer levee)

Breach of western edge of the former “inner berm” levee provides tidal connection to NBM but still very limited tidal connection to AM due to c. 1930 levee. A portion of the inner mud flat was deep enough that it maintained an open water embayment whereas much of the area that would previously become desiccated was now subject to diurnal tides.

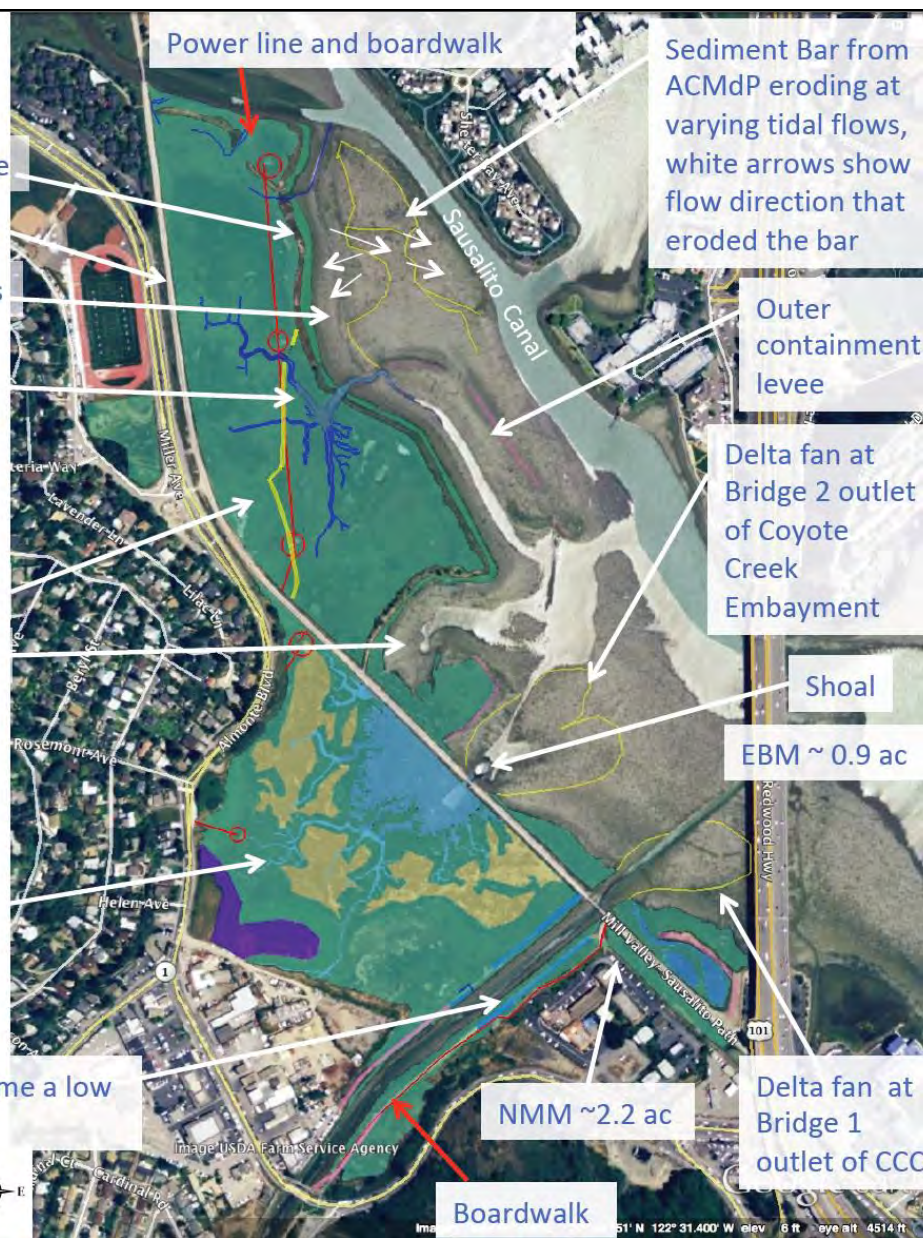
Changes in Modern (2013) and Historical Areas of Marine and Estuarine Wetlands

Map and Data Source: California EcoAtlas San Francisco Estuary Institute, www.ecoatlas.org

2013	116, 117. 118. 119	Net historical decrease in the area of Richardson Bay	<p>A comparison of the historical 1851 head of Richardson Bay marshes to modern conditions of 2013 is provided in Image Ref #116. Separate analyses are done for the whole Bay and its smaller southern arm that extends between Sausalito and Strawberry Point to Mill Valley. The Bay as a whole has 80% less marshland. It has 14% less mudflat and subtidal area. It's 27%</p>
