Bothin Marsh Geomorphology, Ecology, And Conservation Options

Chapter 3: Environmental History of Intertidal Habitats in Richardson Bay with Emphasis on Bothin Marsh

On behalf of
Marin County Open Space District

January 2018

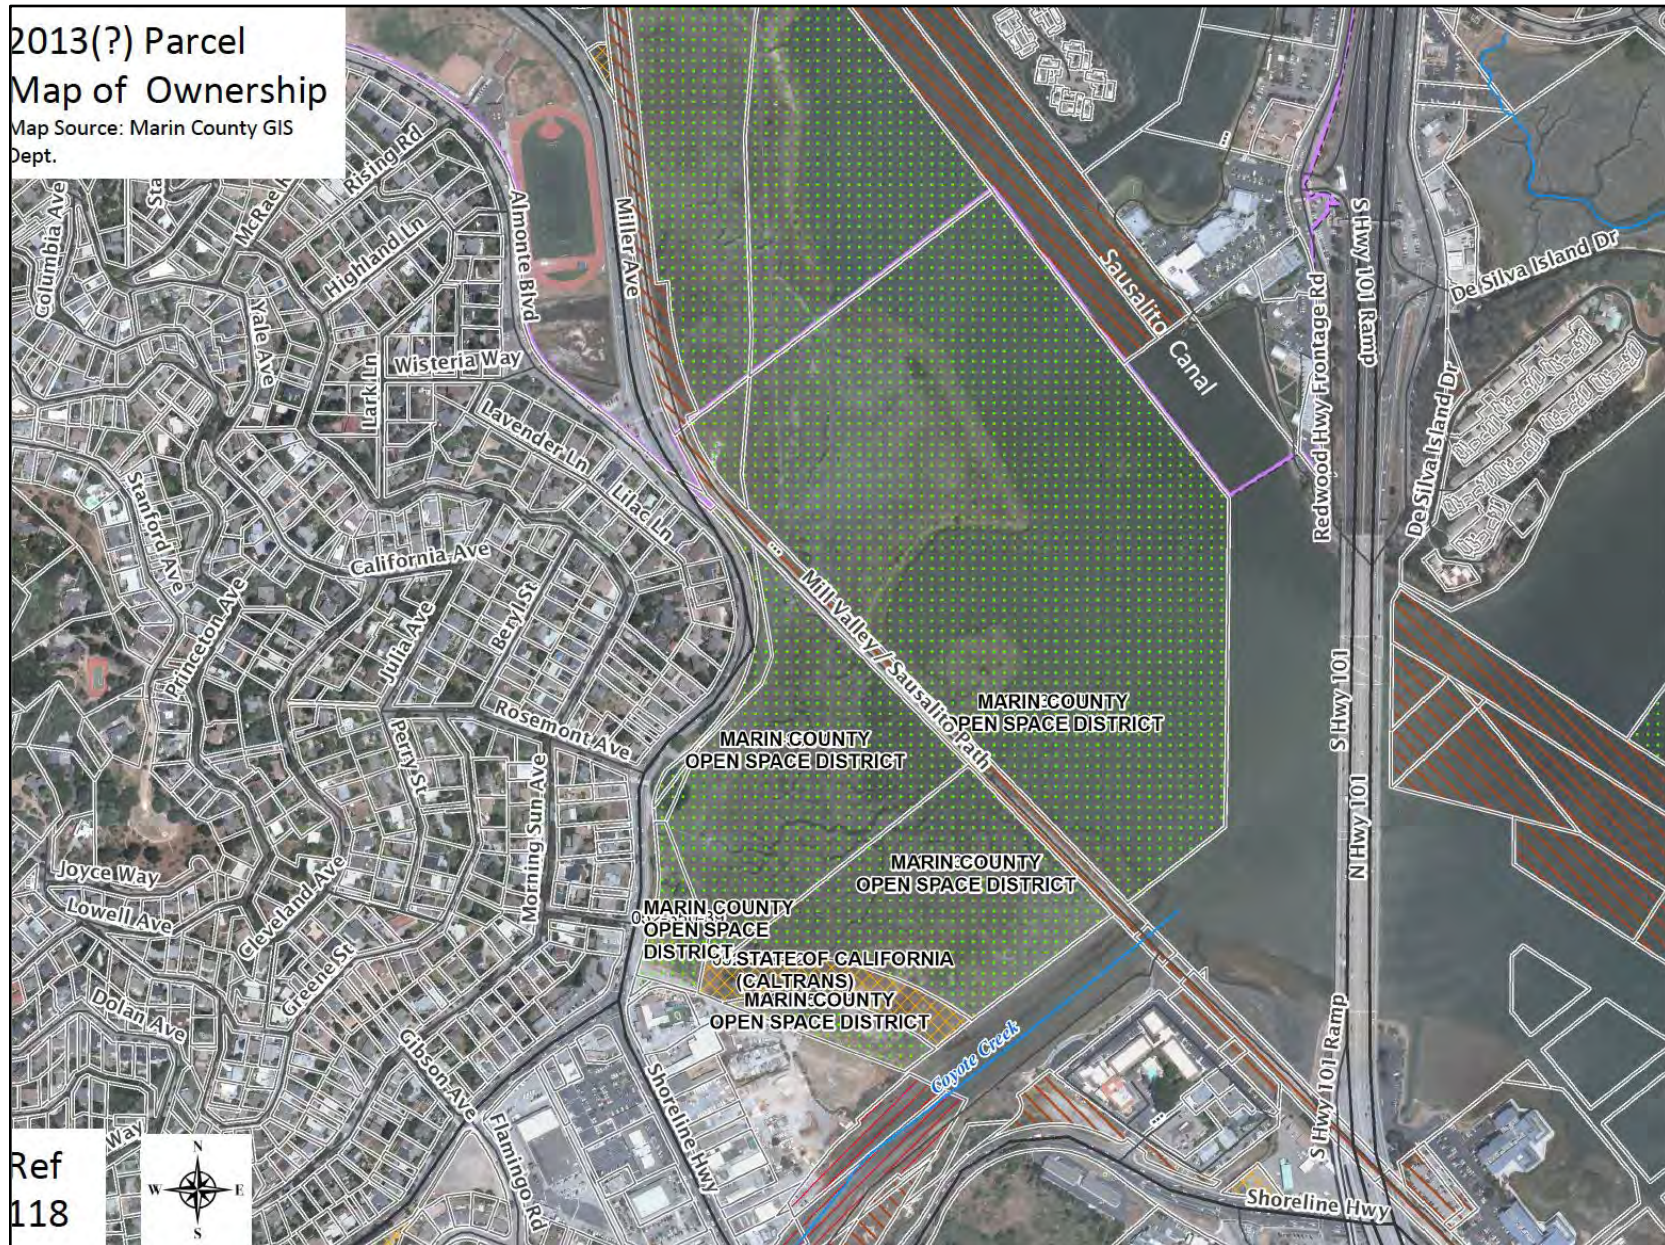
Extent of Coyote Canal and South Bothin Marsh Drainage Areas

The dramatic reduction in drainage area to SBM was caused by diversion of Coyote Creek and construction of the CCC for flood control. Modern SBM has been robbed of upland fluvial sediment supply.

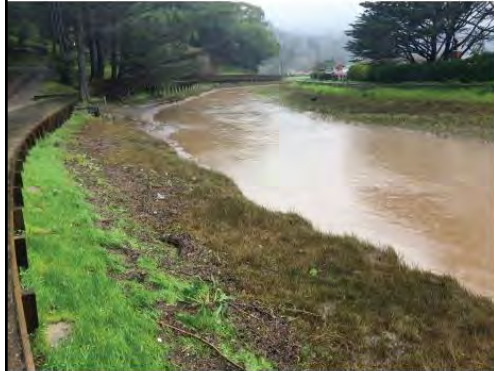
Sediment-rich water in Coyote Creek

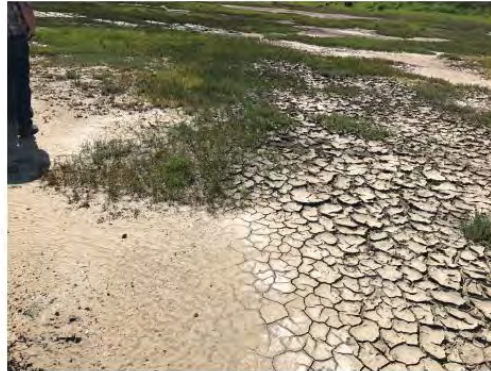
Desiccated backshore areas affected by muted tides

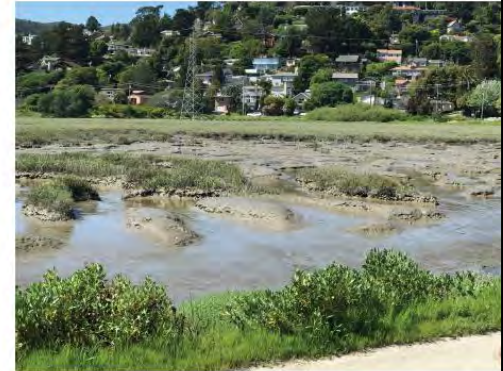
Channels deepening and erosion in the mudflats of the Coyote Creek Embayment

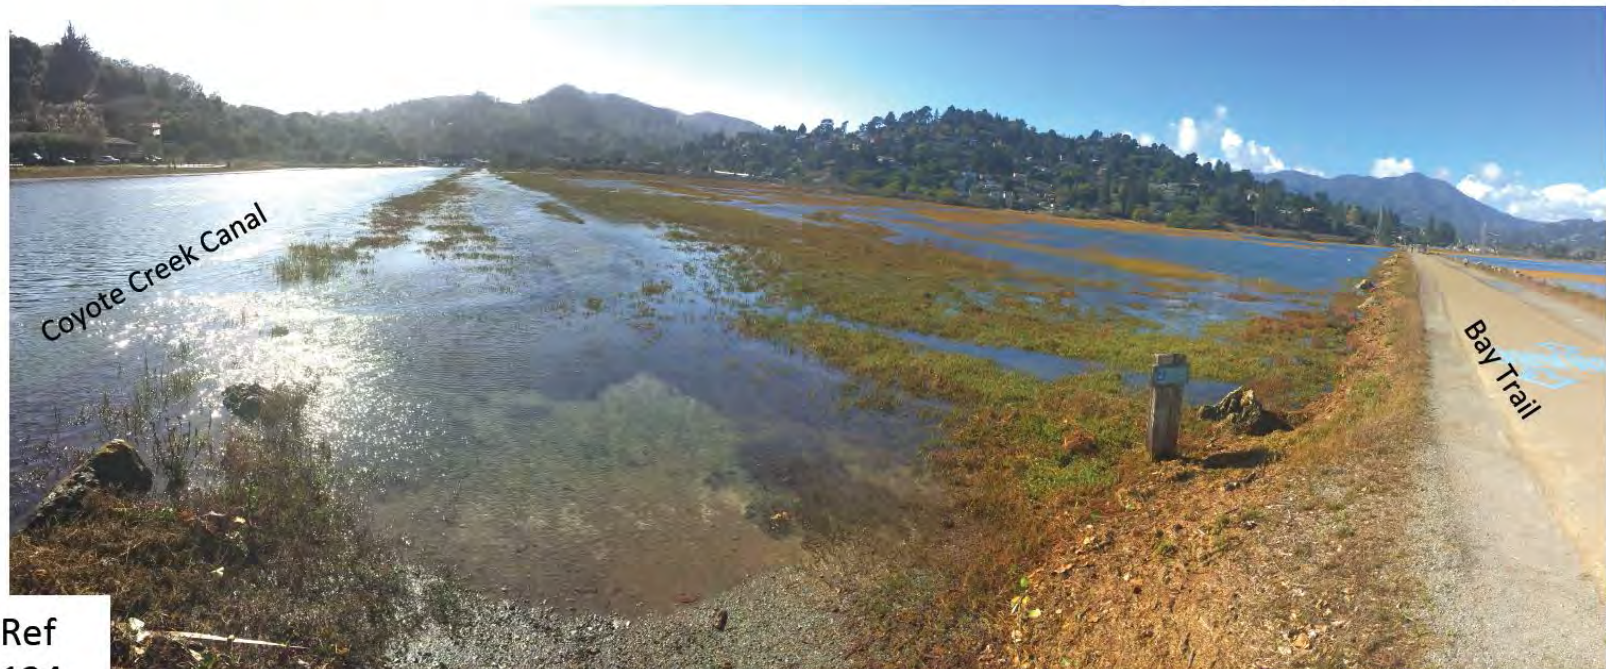
Ref
124

Looking northwest at high tide flowing from Coyote Creek Canal into the South eastern corner of Coyote Creek Embayment.

2017	123, 124, 125	Evidence of loss of high elevation marsh within SBM	<p>The photograph in Ref Image #123 show a very high tide where water is pouring out of South Bothin Marsh over the low north bank levee of the Coyote Creek Canal. This represents what will become an increasing condition with sea level rise, and will likely change much of the tidal dynamics of the marsh. This photo shows that if Coyote Creek were at a very large flood</p>

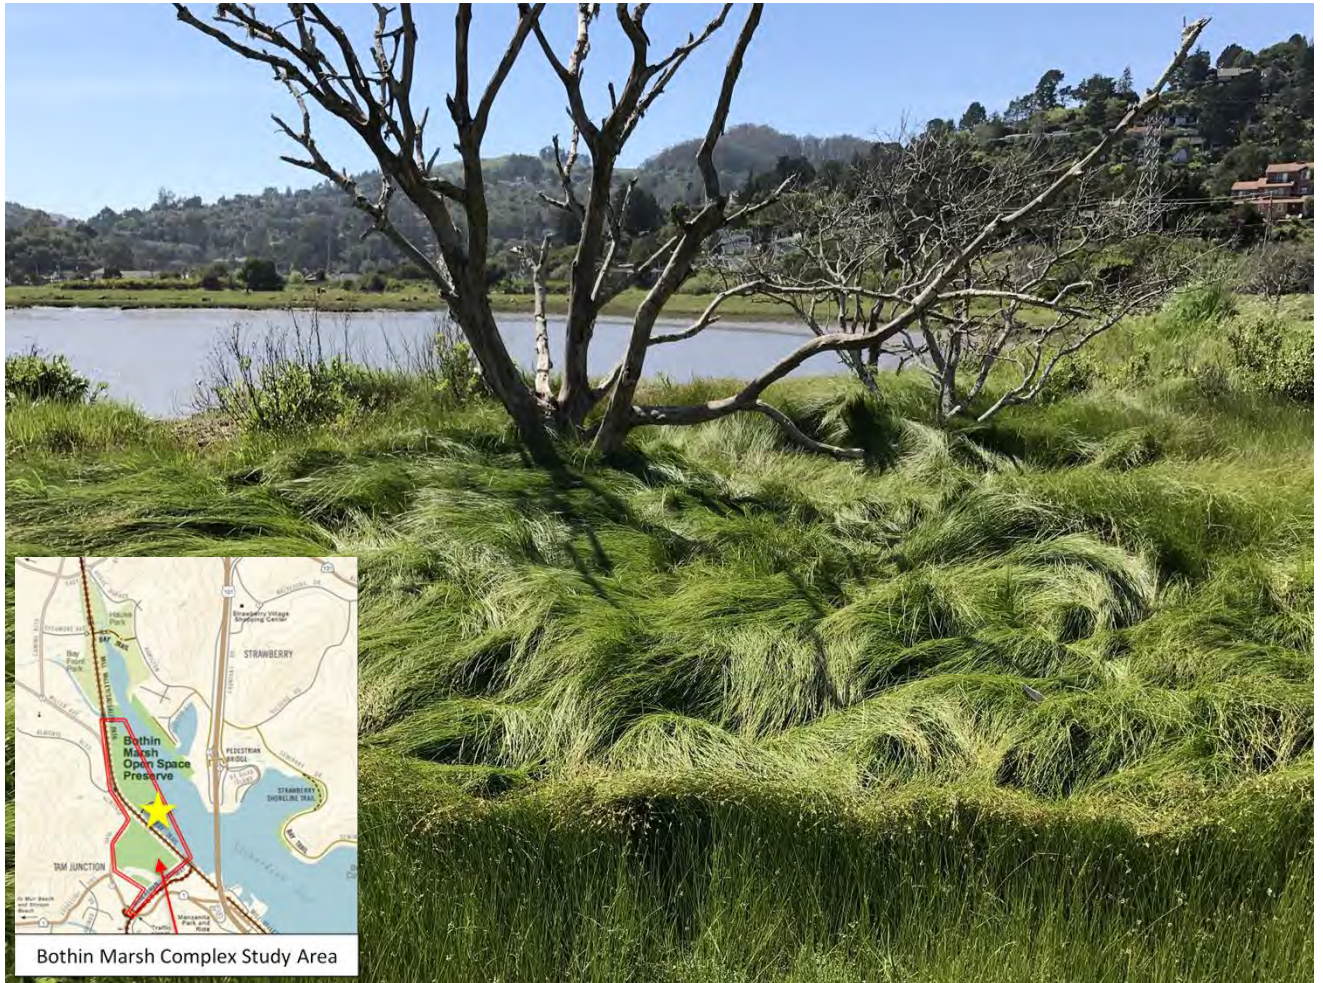
Chapter 3 final figure. South-facing view of native brackish tidal marsh vegetation with shallow roots flourishing on the leached sediments at the top of an historical unnatural levee along the southeastern foreshore of North Bothin Marsh, beneath planted shrubbery killed by salt water intrusion into its deeper root zone, due to sea level rise.
