# PRESERVATION ARCHITECTURE

July 31, 2015

## PHOENIX CABIN HISTORIC STRUCTURE REPORT

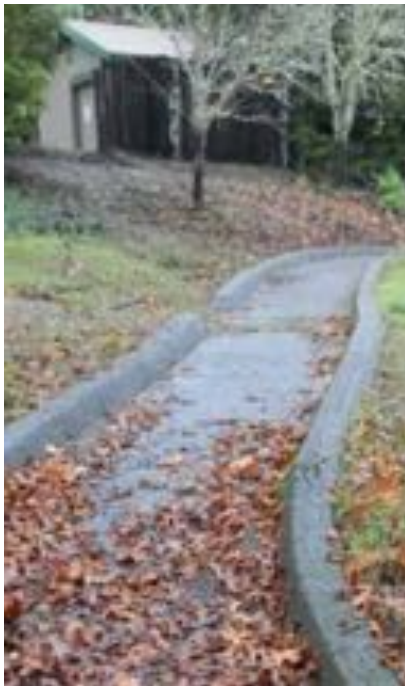
Specific site conditions are limited since the Cabin is essentially freestanding and has no specifically related outdoor areas with the exception of parking and an entry path. The parking is located along the driveway above and to the north. The asphalt-paved entry path descends the slope in a meander, arriving at the rear porch. Both parking and entry pathway are improved to no more than a basic extent — the parking is unpaved and circumstantial, and the path while paved is makeshift. At the front of the Cabin, there is a gate in the fence at the fire road, but which is unused, and there is no associated front entry path.

**Fig.29 – Entry path (with pumphouse/toilet room above)**

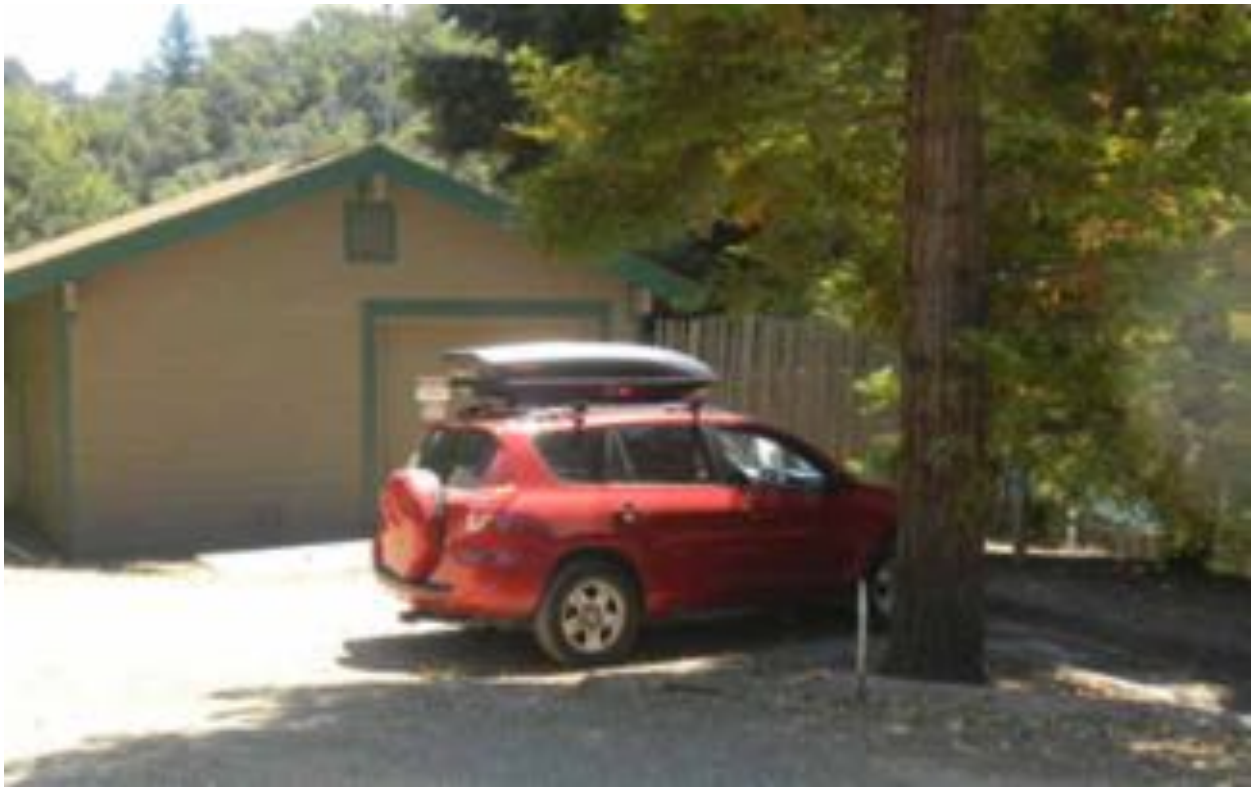
**Fig.31 – Site - Accessible parking space above Cabin (pump house at left)**

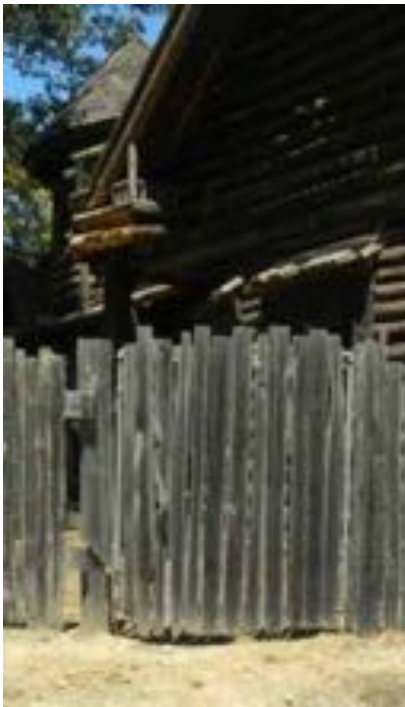
**Fig.32 – Front gate & fence**

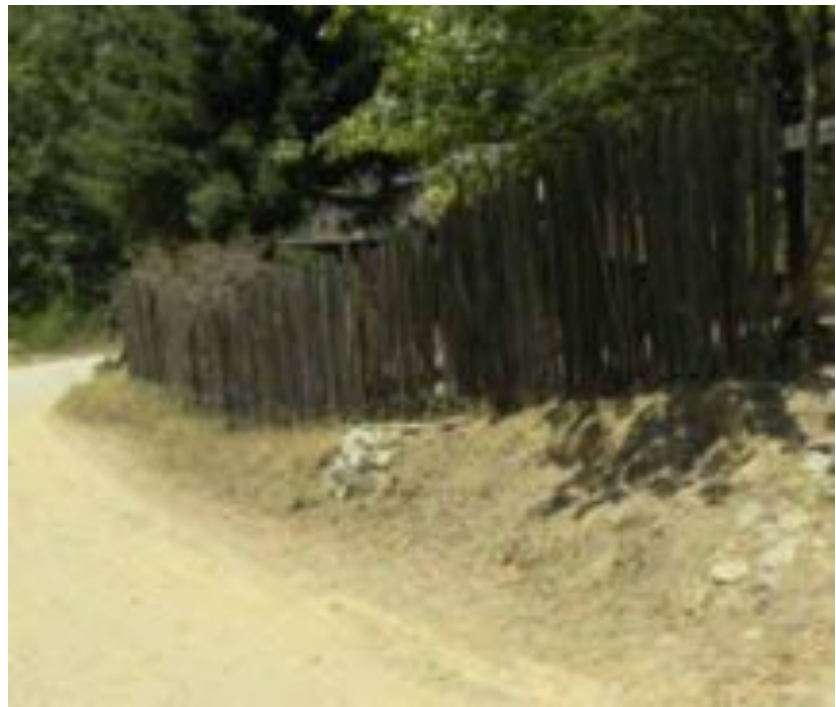
**Fig.33 – Site - Fence along road at east side of Cabin**

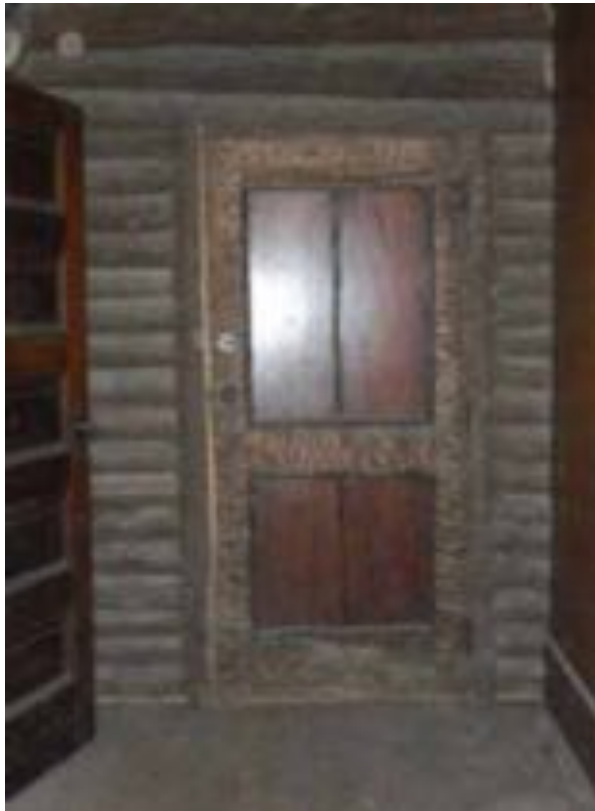
While the interior retains remnants of its domestic origins, and specifically the arrangement and types of rooms, the interior spatial divisions may be a limitation to reuse. The entry vestibule is situated in the very center, would serve little purpose in some reuse situations, and has four doors serving this little space. The bath and closet are equally small and would serve little purpose in some reuse situations.

**Fig.46 – Entry vestibule and door**

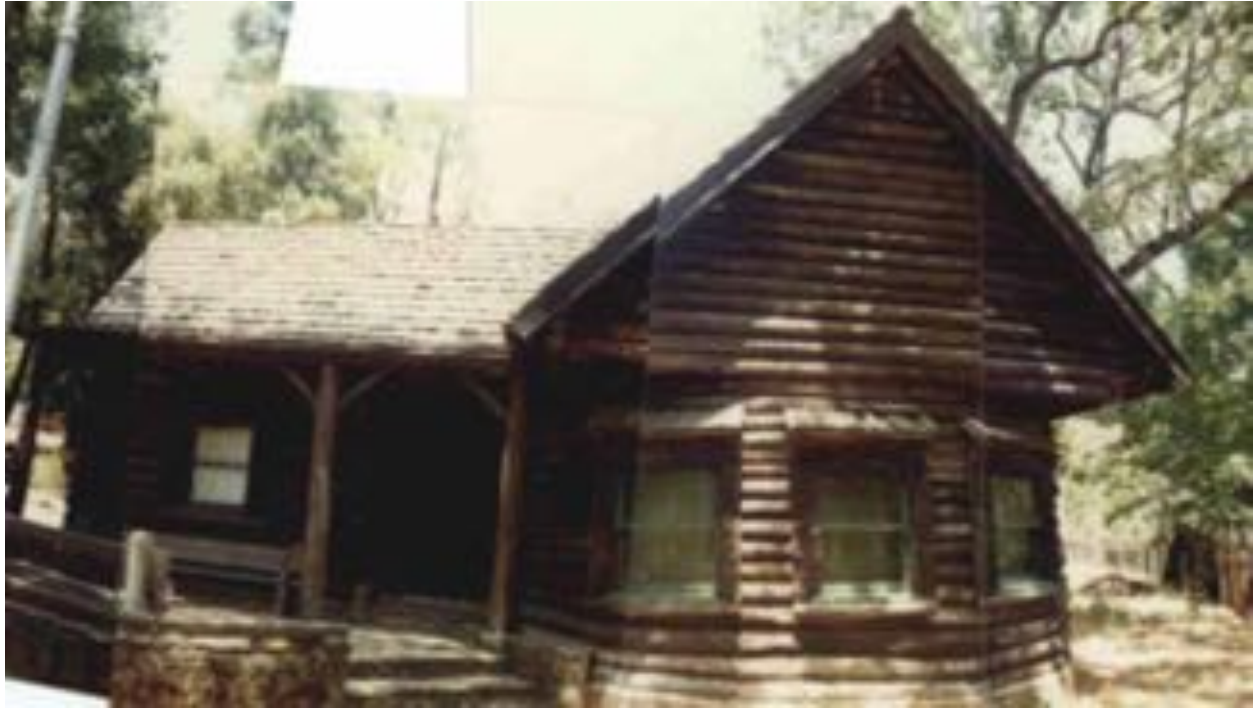
**Fig.53 – Front, with previous porch - c1980s (MMWD)**

interpretation, inappropriately so, as the cupola is in fact structurally failing as well as purposeless. Thus, at the front porch, the porch roof and cupola should be removed and replaced with a new, simple front porch. Pre-1989 images of the Cabin show the front porch with a simple post-supported shed roof (fig.48). The front porch could also be redesigned to make the front entry accessible, if possible, from the fire road and/or from an adjoining parking space. A front patio-like area is an additional possibility, along with the possibility that such a space could be opened to the fire road or, if not fully open, with front gates that allow visibility and access at the front.
