# PRESERVATION ARCHITECTURE

July 31, 2015

## PHOENIX CABIN HISTORIC STRUCTURE REPORT

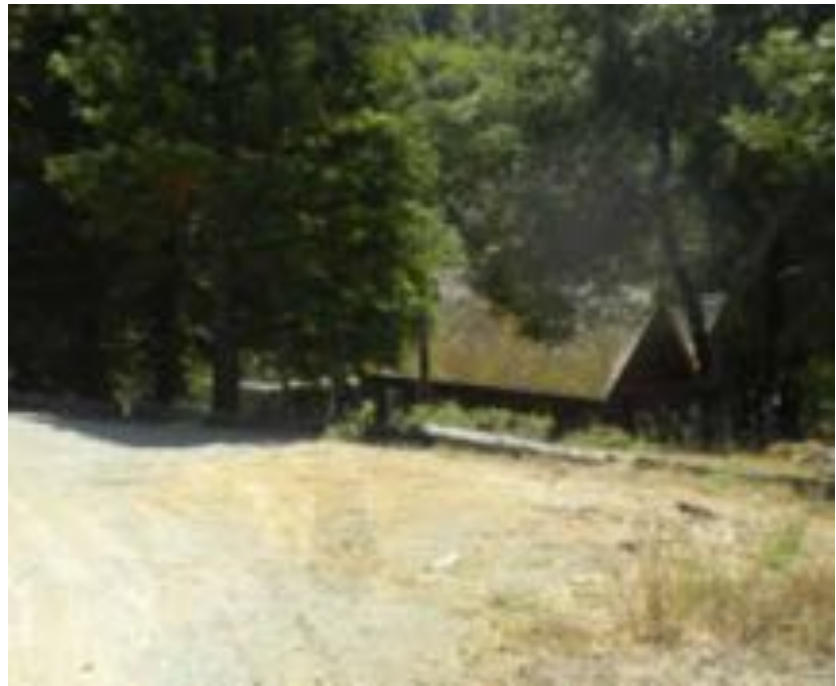
**Fig.30 – Site - Parking area above Cabin**

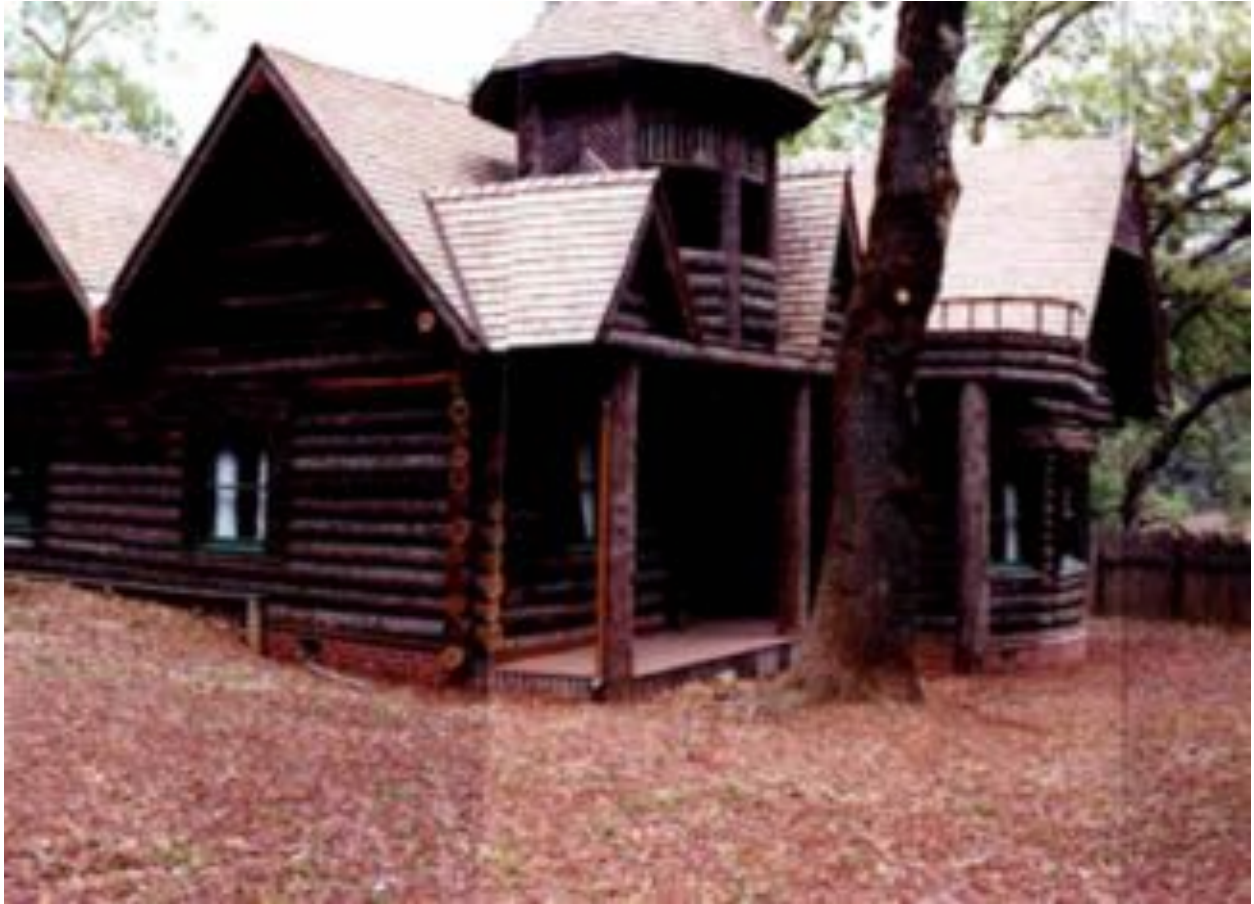
**Fig.34 – Front porch - 1991 (MMWD)**

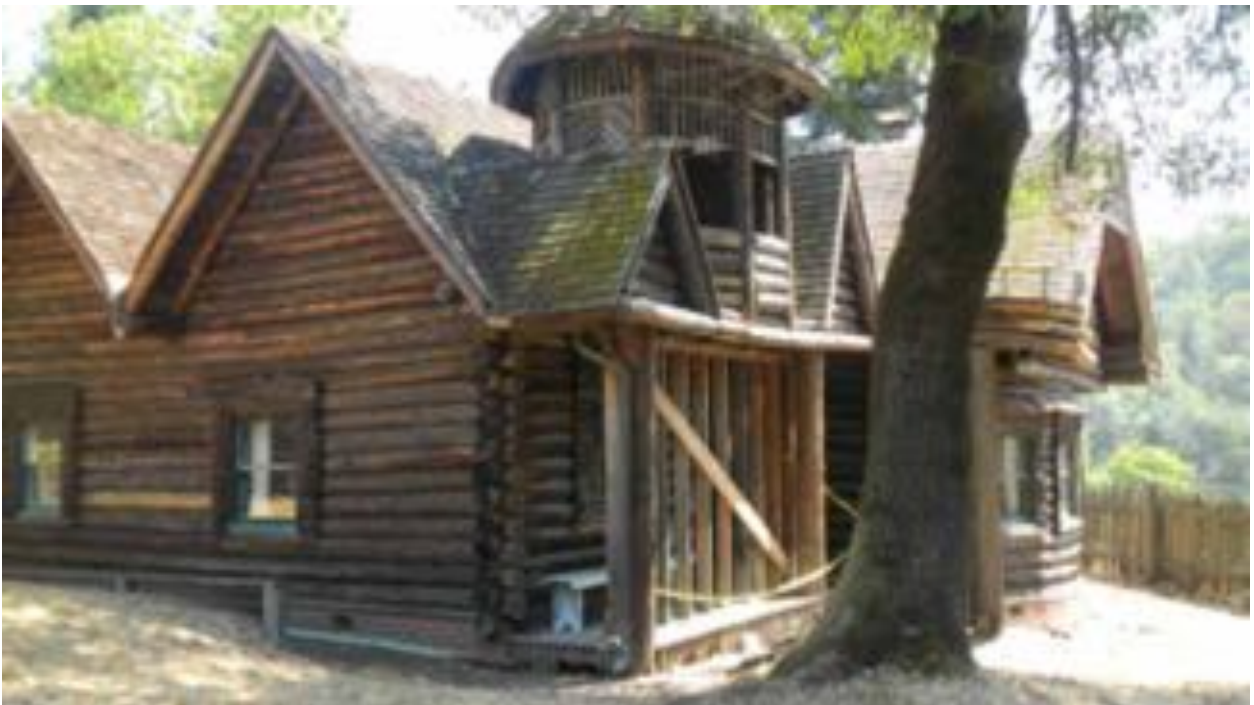
**Fig.35 – Front Porch - 2014**

In general, the Cabin's exterior conditions can be summarized as deteriorating, with decay largely unarrested and with localized structural failure. The only areas and features that appear to be in good condition are the Cabin's overall form, its front door and curly redwood trim boards, some of the logwork, and its non-historic concrete foundations. The 1989 cedar shingle roofing is in good-to-fair condition, yet its ridge and hip shingles having just been replaced.

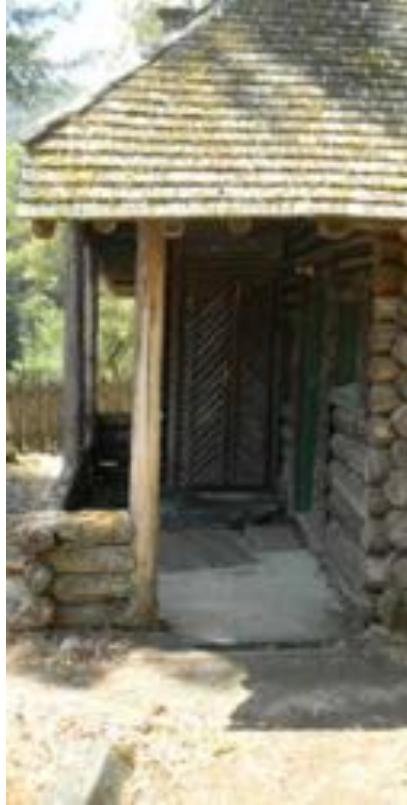
**Fig.40 – Rear porch**

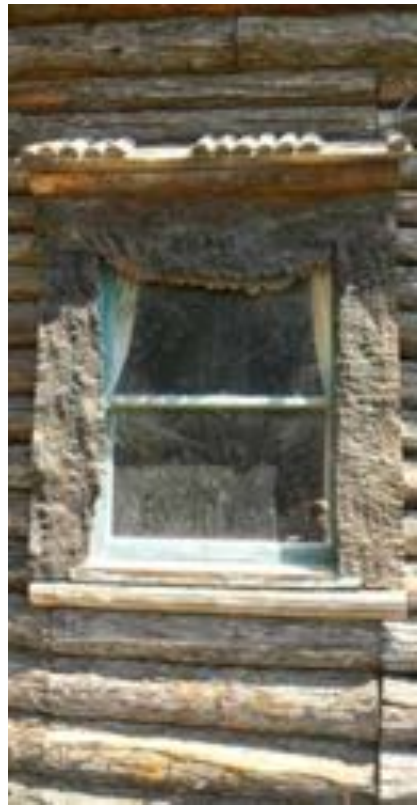
**Fig.41 – Front window**

- Wood windows – Marginal wood and glazing materials and extensive paint deterioration, requiring repair, including approximately 50% replacement.
- Wood doors – Front, good; rear, fair and requiring repair and repainting.

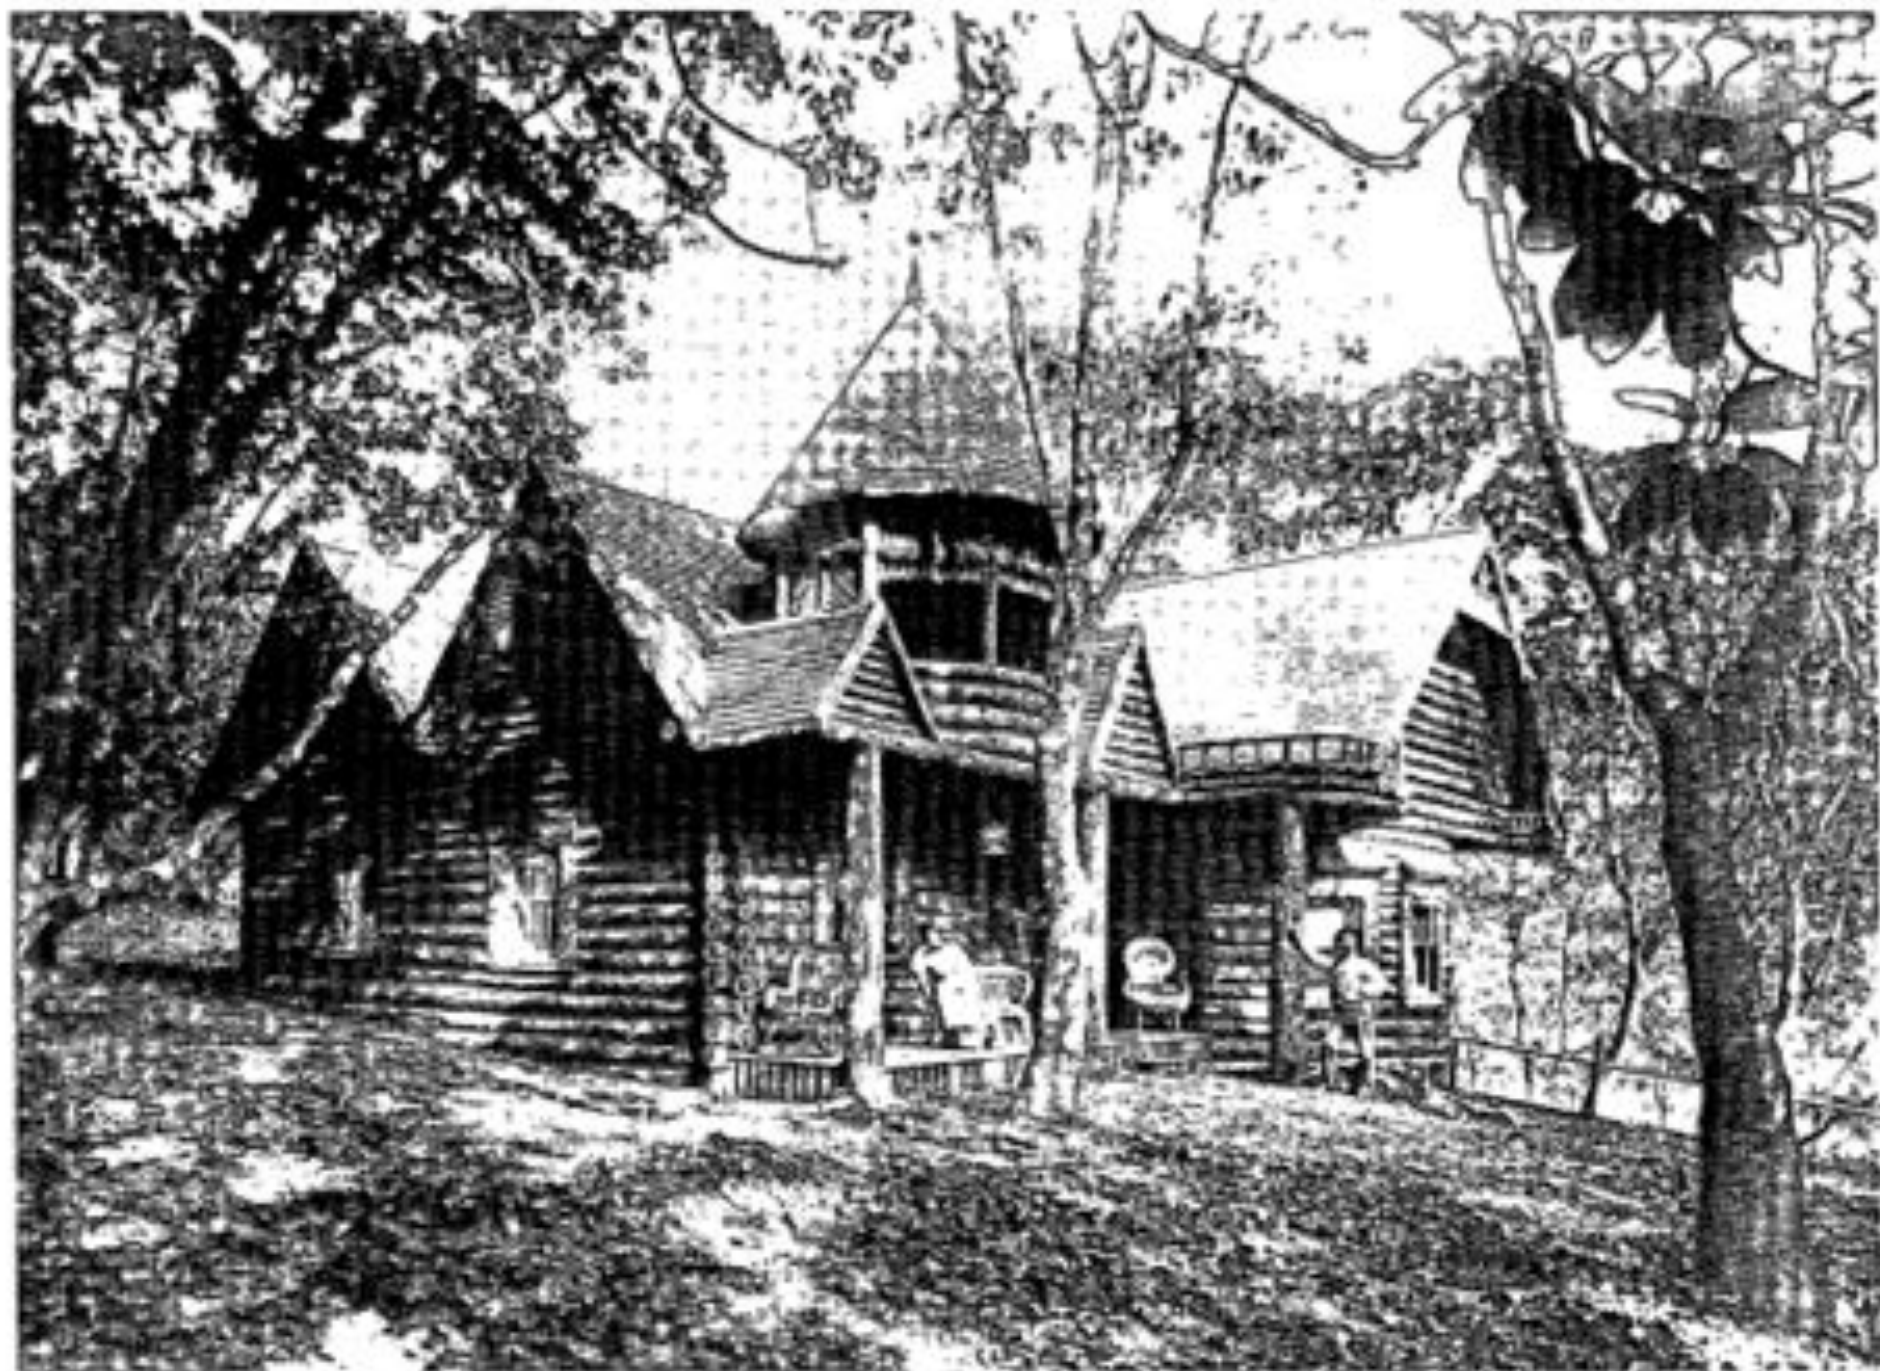
Photo taken around 1900 by Lorillard & Brett of San Raphael. Shows original porch, cupola, and roof gables. Also note gable end ornamentation above bay window.

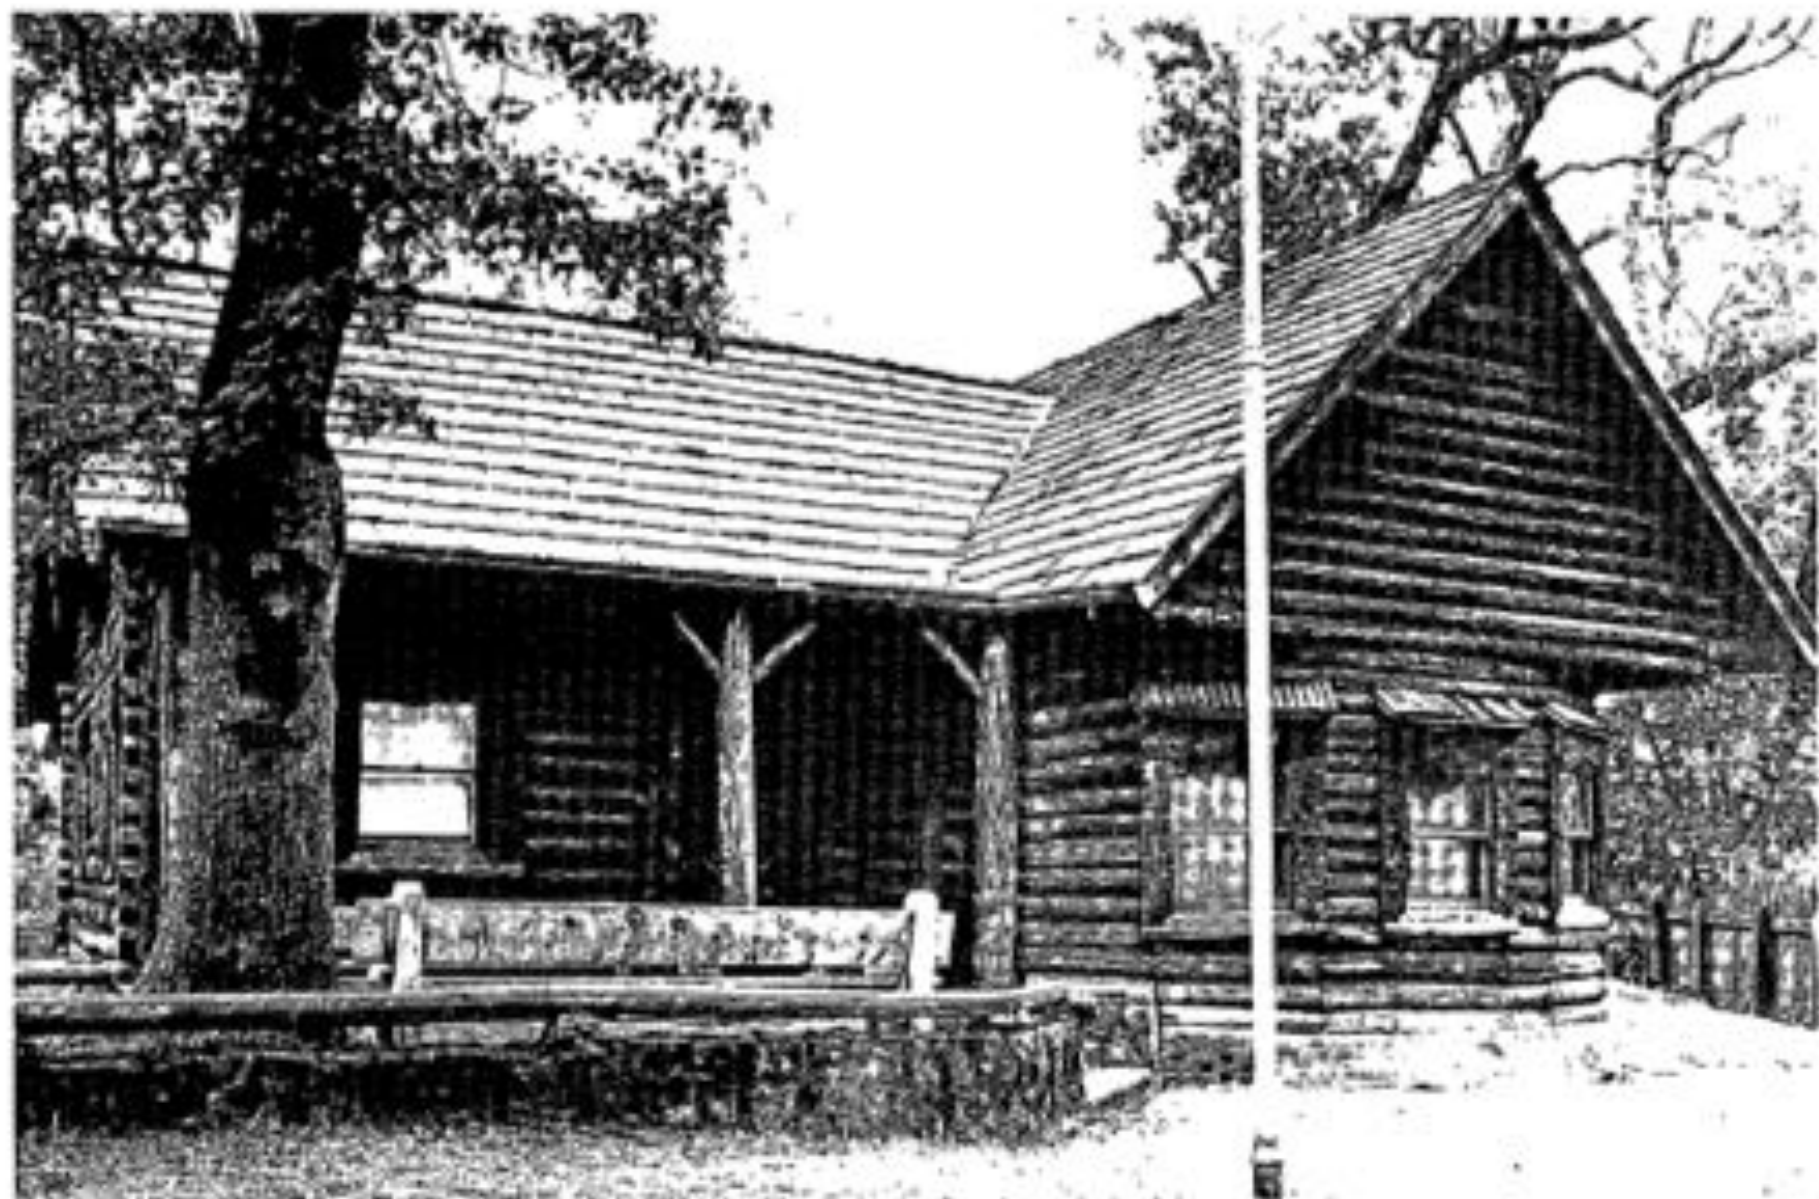
Southwest (front) elevation looking northeast.
